4220 Baxter Road  
 Anchorage, Alaska

**Test Pit Soil Sample Results  
 (June & July 2025)**

Figure 4

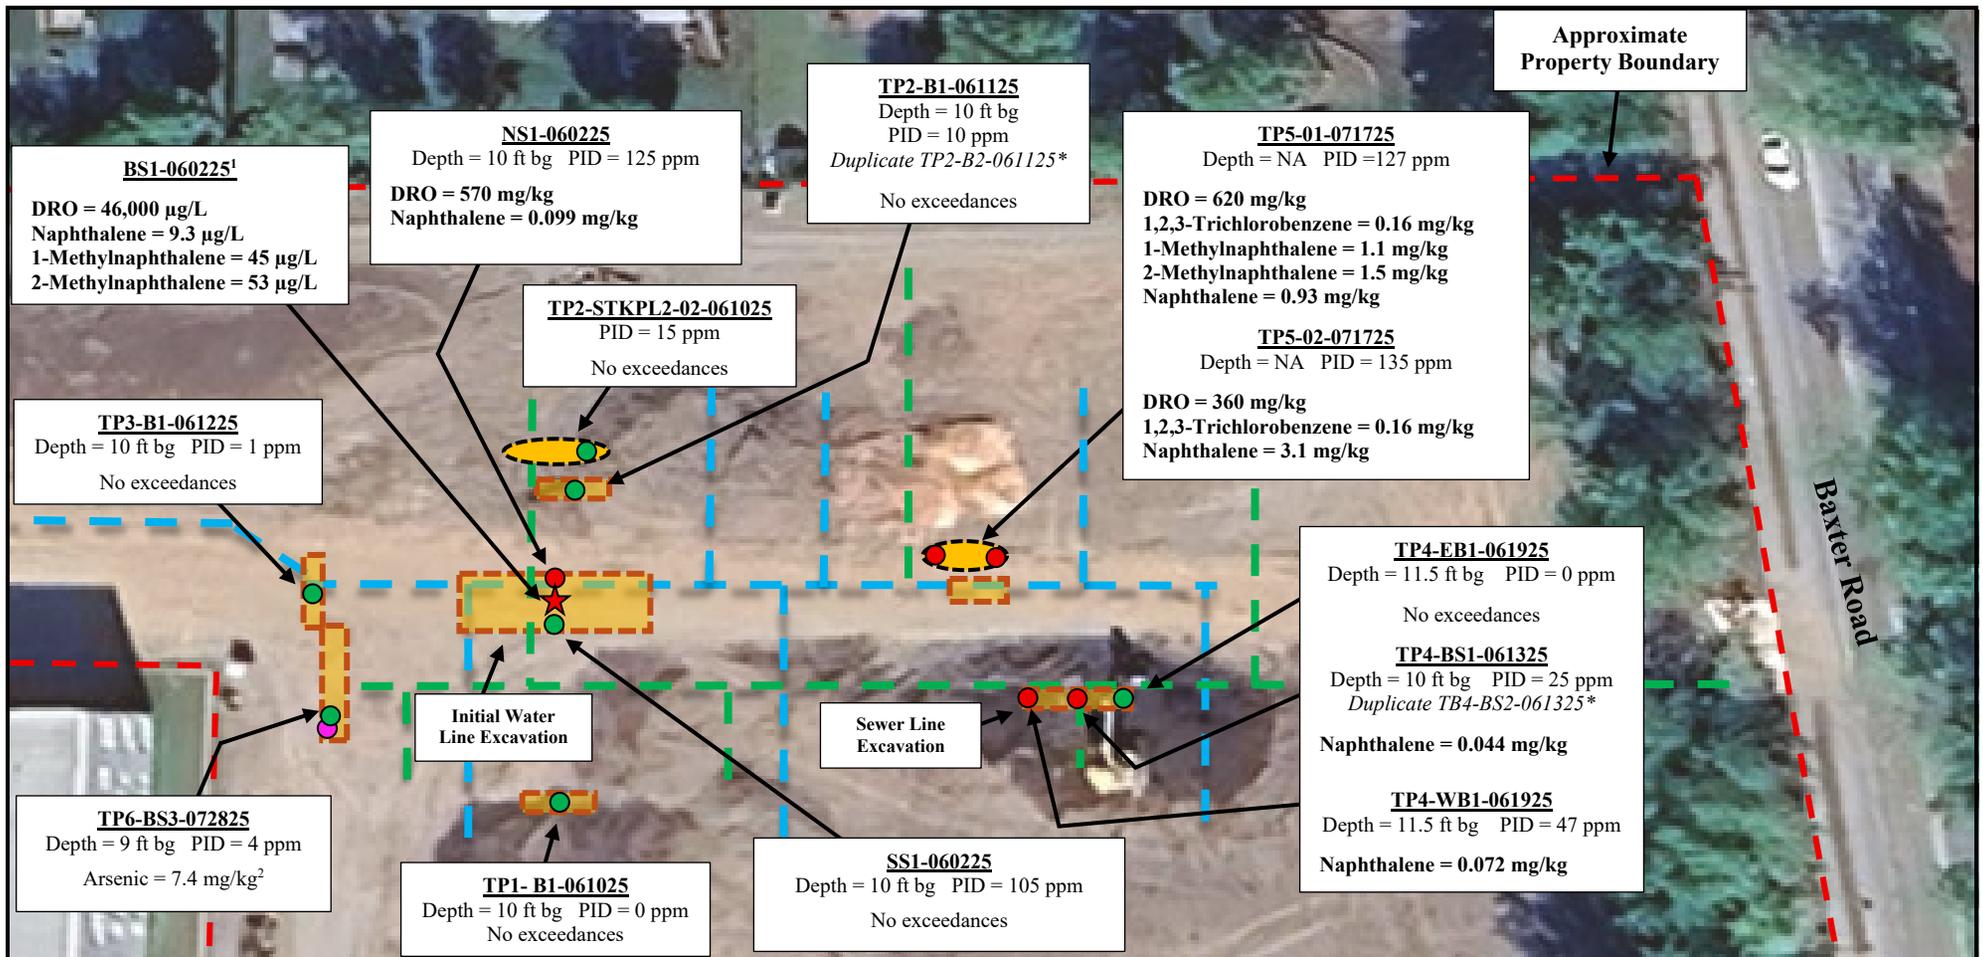
<sup>1</sup> This exceedance is likely from a perch water zone and not representative of site-related groundwater contamination

<sup>2</sup> Arsenic exceeds ADEC cleanup criterion; however, the reported concentrations are typical of naturally occurring arsenic concentrations in Alaska and should not be considered a contaminant of concern

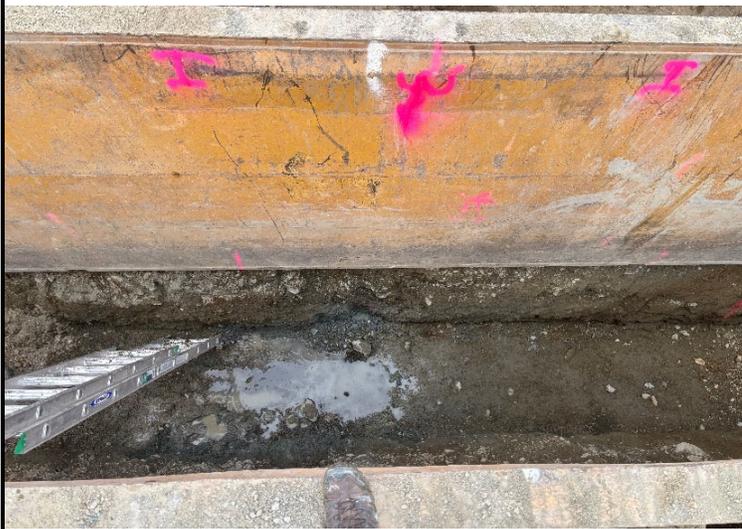
Photo 1. Looking Down at Perched Water in Trench.

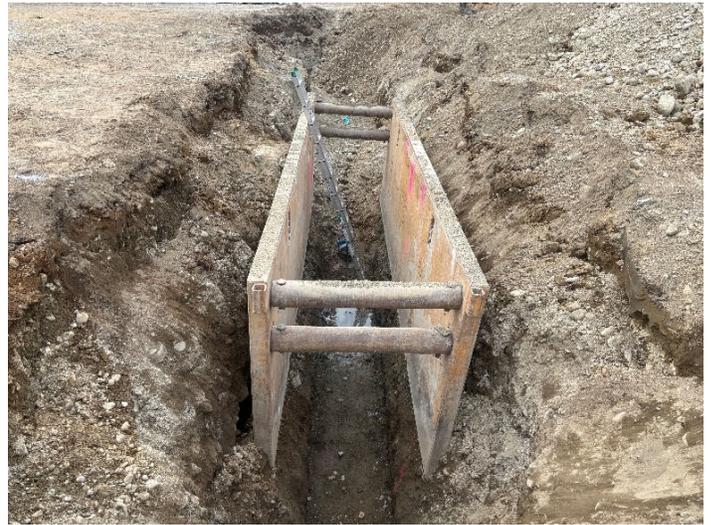
Photo 2. Looking Along Trench at Perched Water

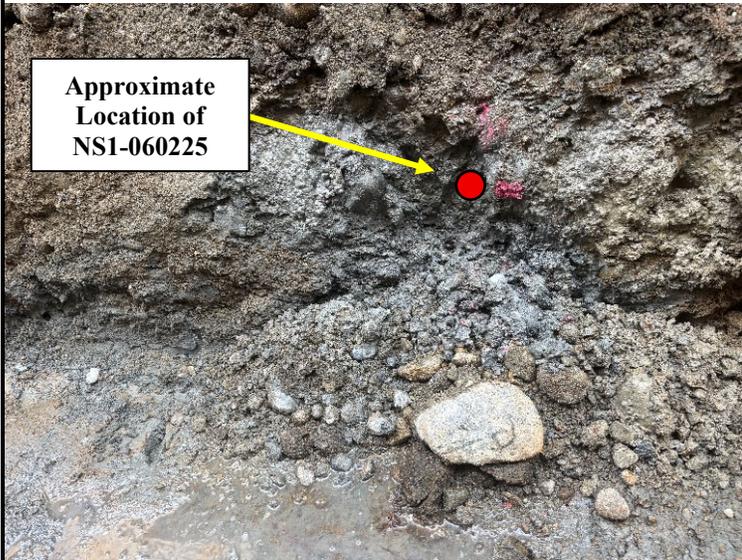
Approximate  
Location of  
NS1-060225

Photo 3. Looking at Saturated & Stained Soil

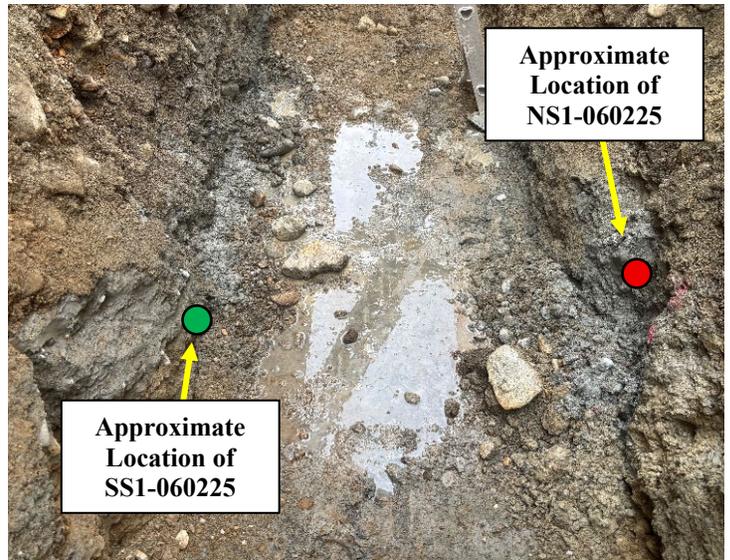
Photo 4. Perched Water and Stained Soils
