**TRACT 1, NORTHWAY BUSINESS PARK SEWARD TOWERS  
ANCHORAGE, ALASKA**

**PHASE I ENVIRONMENTAL SITE ASSESSMENT**

**NOVEMBER 2024**

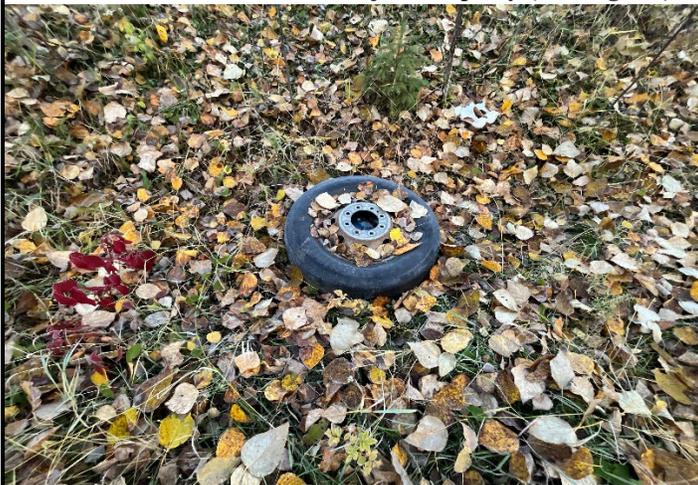
**Photo 5. Discarded Wheel on Subject Property**

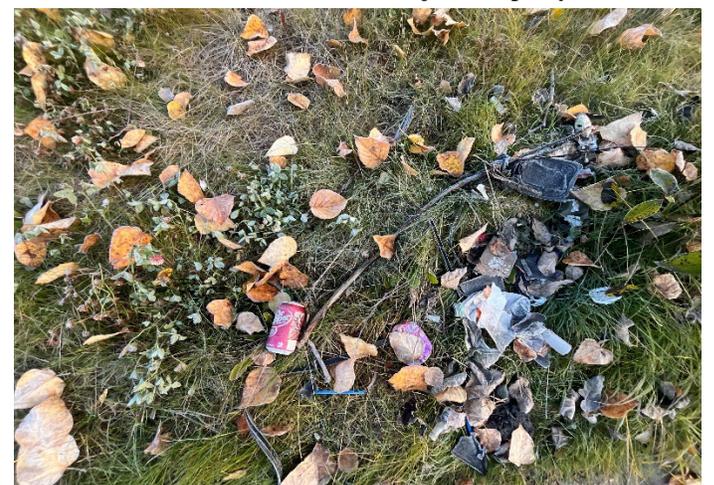
**Photo 6. Winblown Trash on Subject Property**

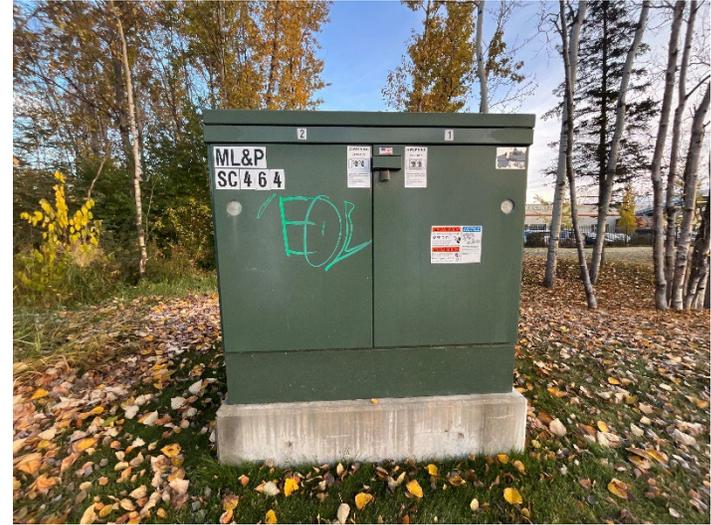
Photo 10. Electrical Switch Cabinet, E of Subject Property

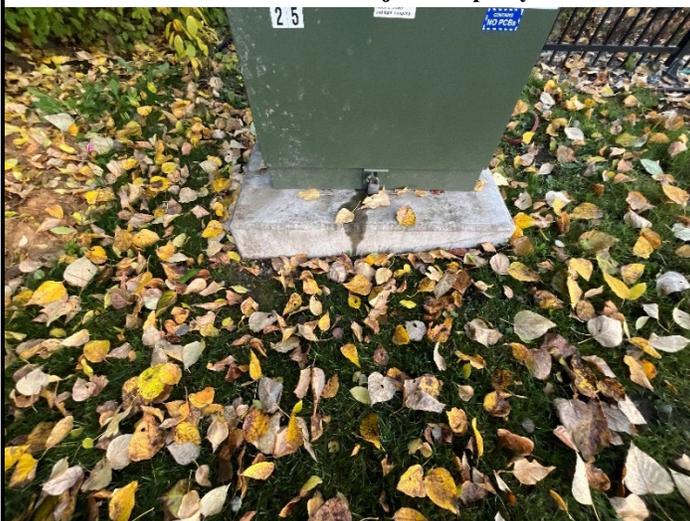
An electrical switch cabinet and a pad-mounted transformer were located just east of the southeast corner of the subject property (Photographs 10 and 11 in Appendix B). The transformer had what appeared to be a small leak on its cement pedestal. The transformer bore a 'No PCB's' sticker (Photograph 11 in Appendix B). A metal fence separated the subject property from the surgery center to the east (Photograph 12 in Appendix B).

Photo 11. Pad-Mounted Transformer - Small Leak (E of Property)
