4220 Baxter Road
 Anchorage, Alaska

**Test Pit Soil Sample Results
 (June & July 2025)**

Figure 4

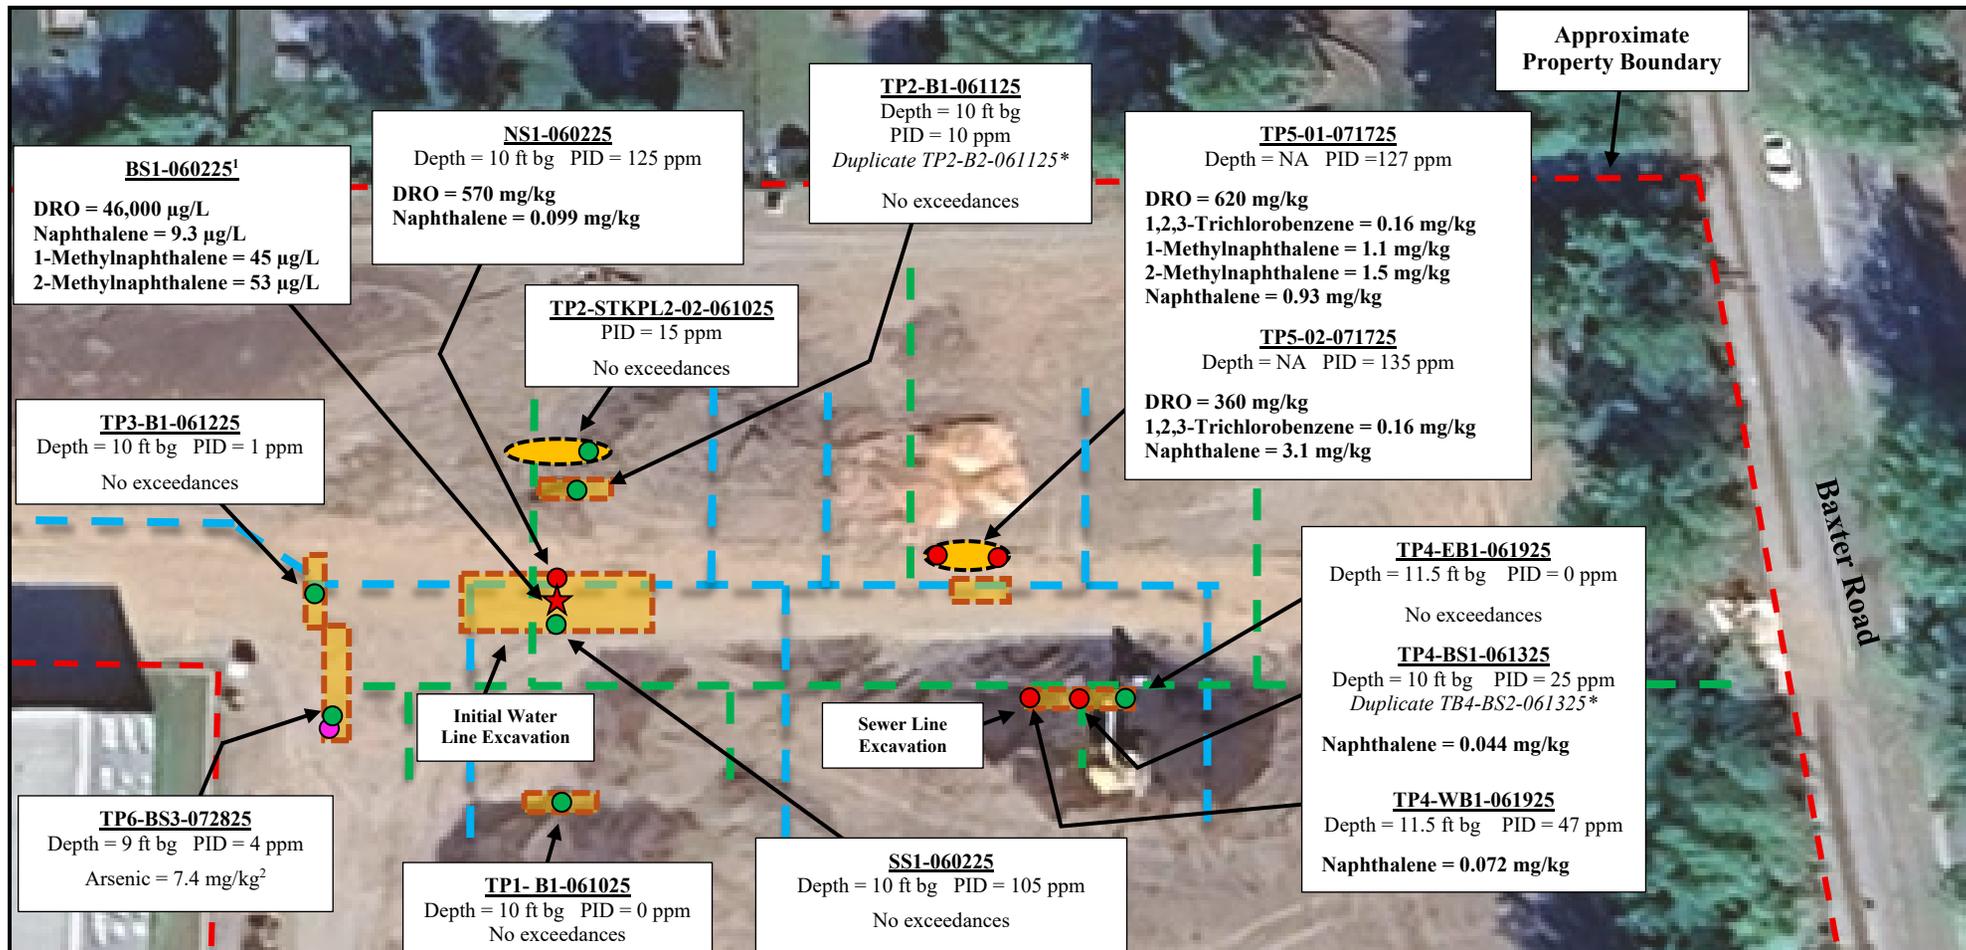
¹ This exceedance is likely from a perch water zone and not representative of site-related groundwater contamination

² Arsenic exceeds ADEC cleanup criterion; however, the reported concentrations are typical of naturally occurring arsenic concentrations in Alaska and should not be considered a contaminant of concern
