GEOTECHNICAL ENGINEERING REPORT
for
CIHA AIRPORT HEIGHTS SENIOR HOUSING
PROJECT (PHASE 1)
ANCHORAGE, ALASKA

NGE-TFT Project #10155-25

RE: GEOTECHNICAL ENGINEERING REPORT FOR THE PROPOSED CIHA AIRPORT HEIGHTS SENIOR HOUSING PROJECT (PHASE 1) LOCATED IN ANCHORAGE, ALASKA

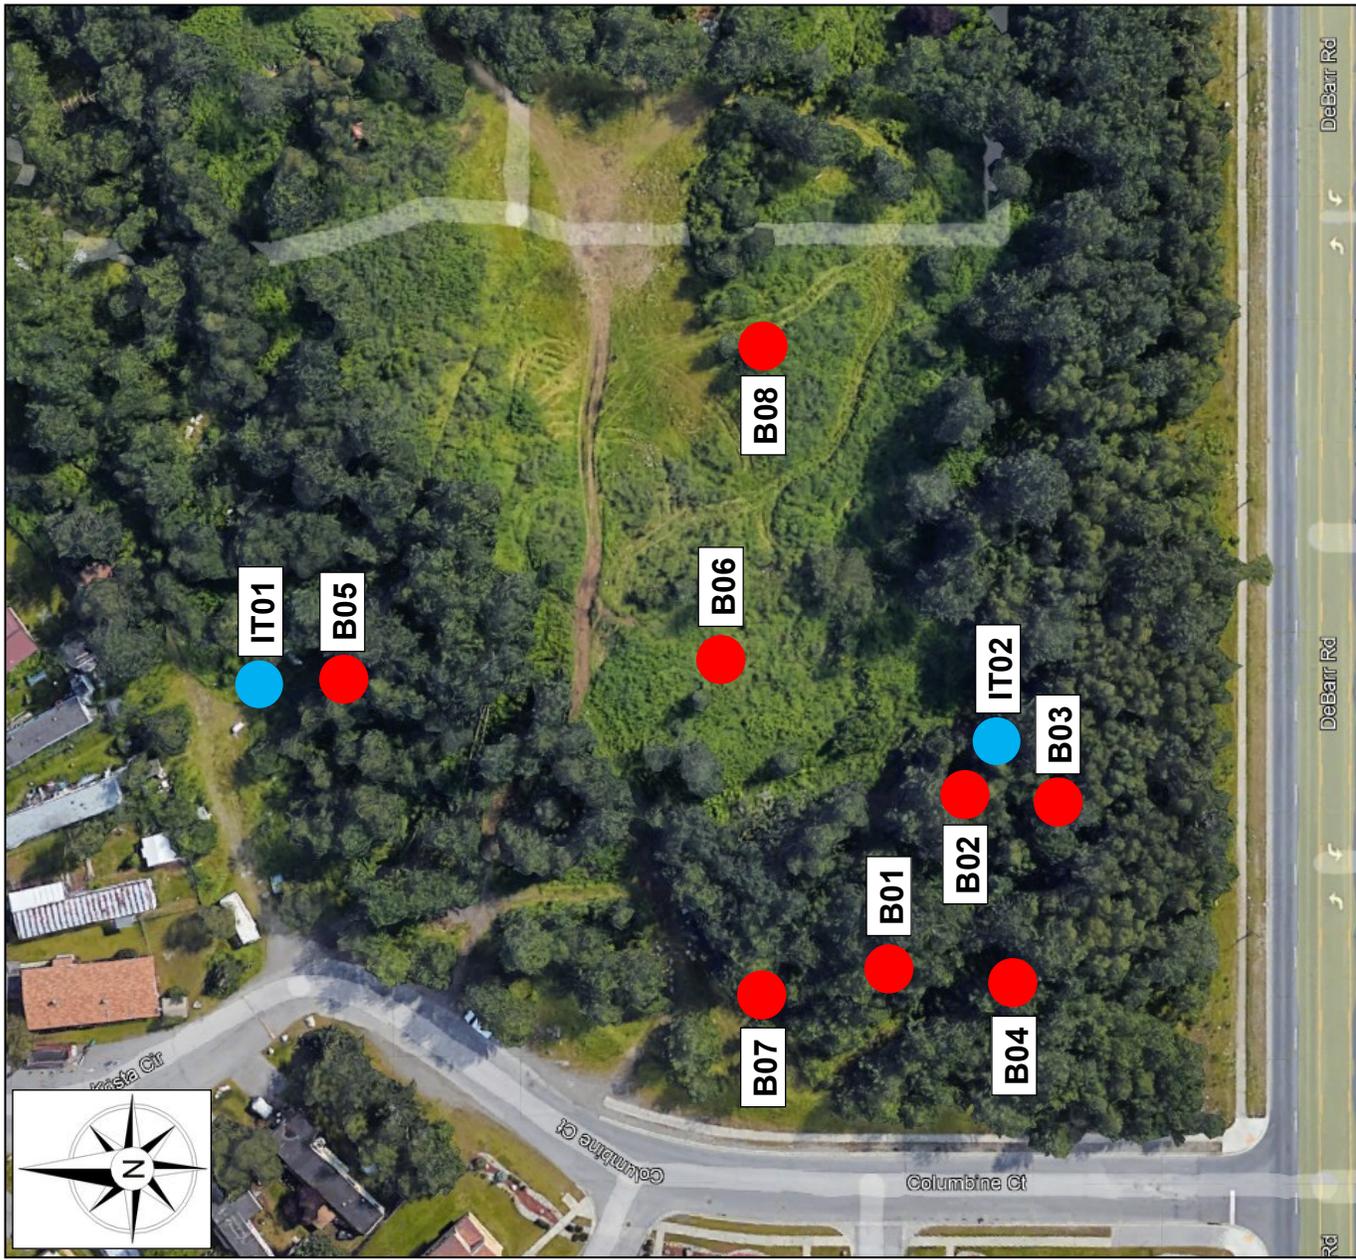
Borehole	Coordinates (N / W)
B01	61.210325 / -149.817198
B02	61.210257 / -149.817509
B03	61.21015 / -149.81671
B04	61.210183 / -149.817201
B05	61.211066 / -149.816376
B06	61.210535 / -149.816382
B07	61.210503 / -149.817287
B08	61.210511 / -149.815509
IT01	61.211176 / -149.816451
IT02	61.210200 / -149.816729

- - APPROXIMATE BOREHOLE LOCATIONS
 - - APPROXIMATE INFILTRATION WELL LOCATIONS
- DATA PROVIDED COURTESY OF THE MOA

Current Site Conditions: (See Figure 2)

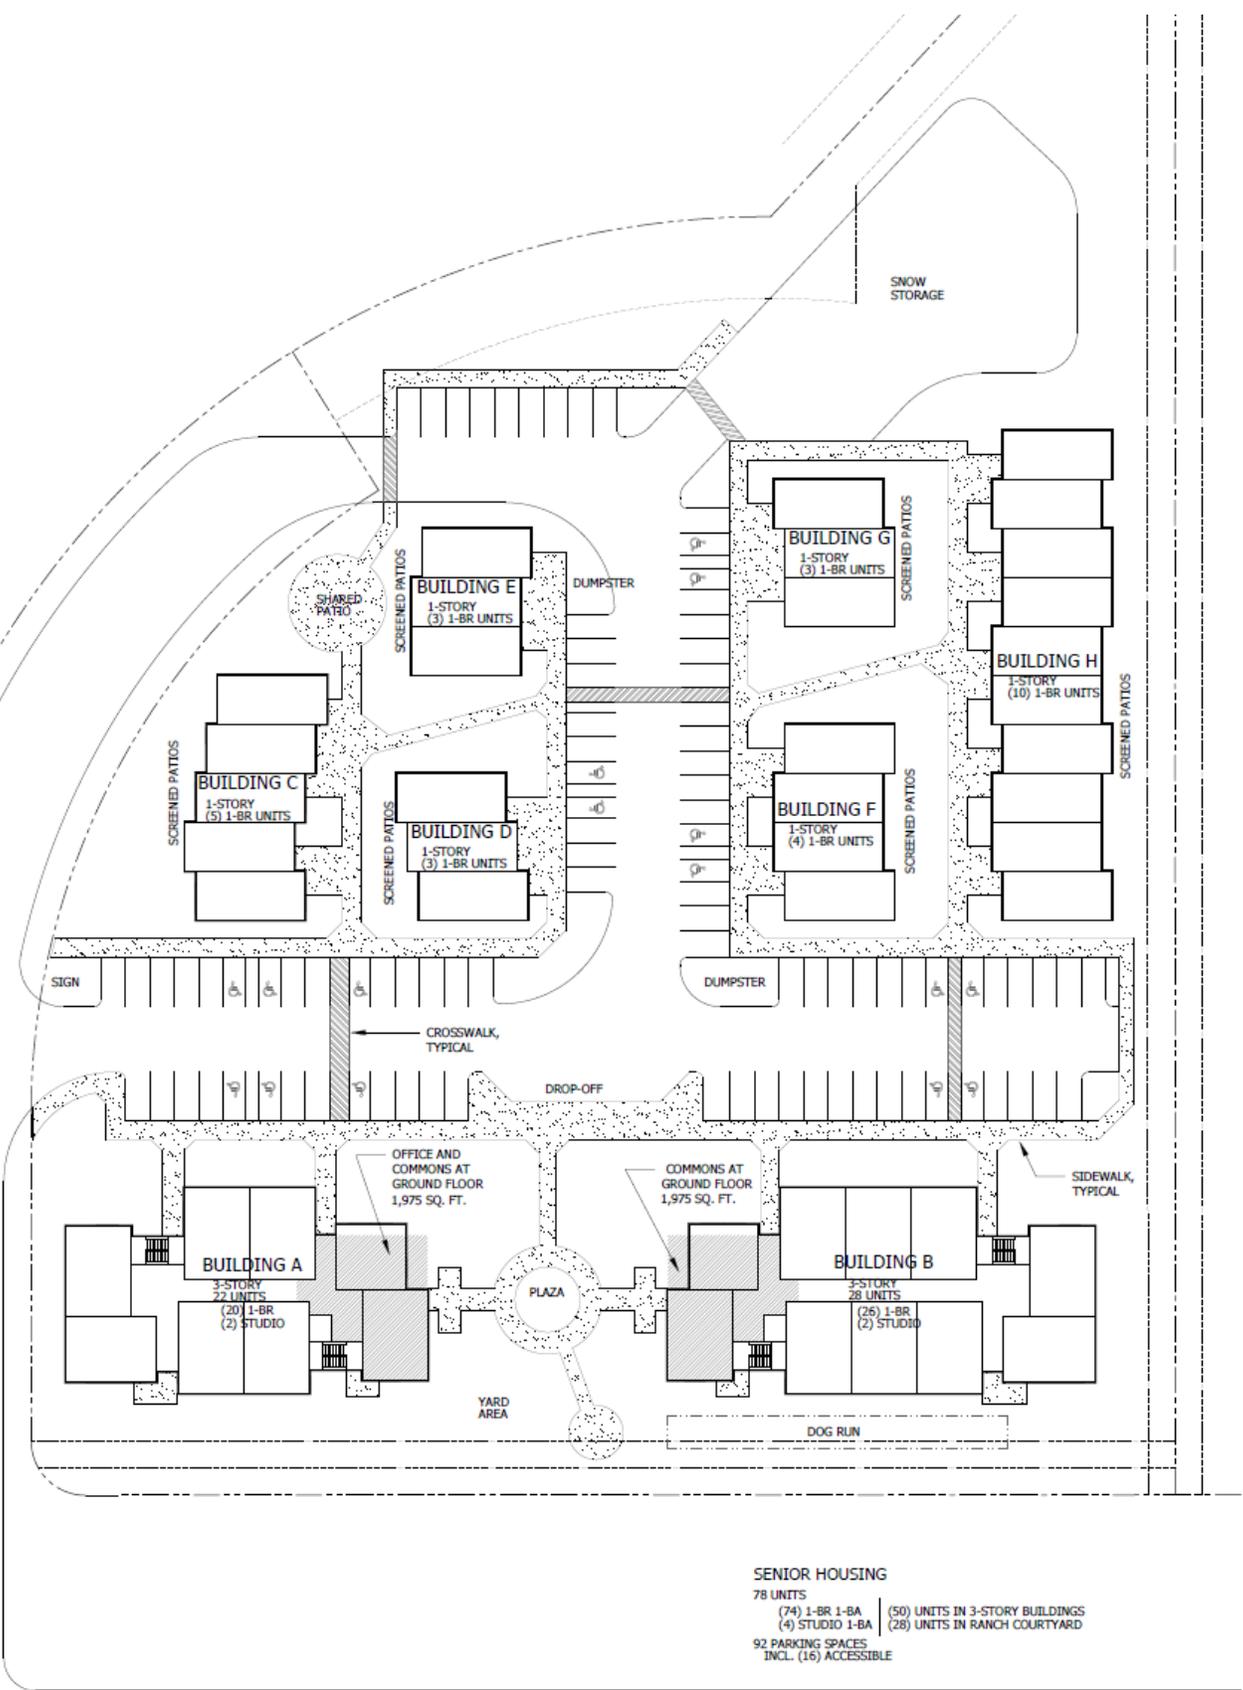
FIGURE TITLE: PROPOSED IMPROVEMENTS	PROJECT ID: 10155-25
PROJECT NAME: CIHA AIRPORT HEIGHTS SENIOR HOUSING PHASE 1	FIGURE NUMBER: 3
PROJECT LOCATION: ANCHORAGE, ALASKA

SENIOR HOUSING
 78 UNITS
 (74) 1-BR 1-BA | (50) UNITS IN 3-STORY BUILDINGS
 (4) STUDIO 1-BA | (28) UNITS IN RANCH COURTYARD
 92 PARKING SPACES
 INCL. (16) ACCESSIBLE

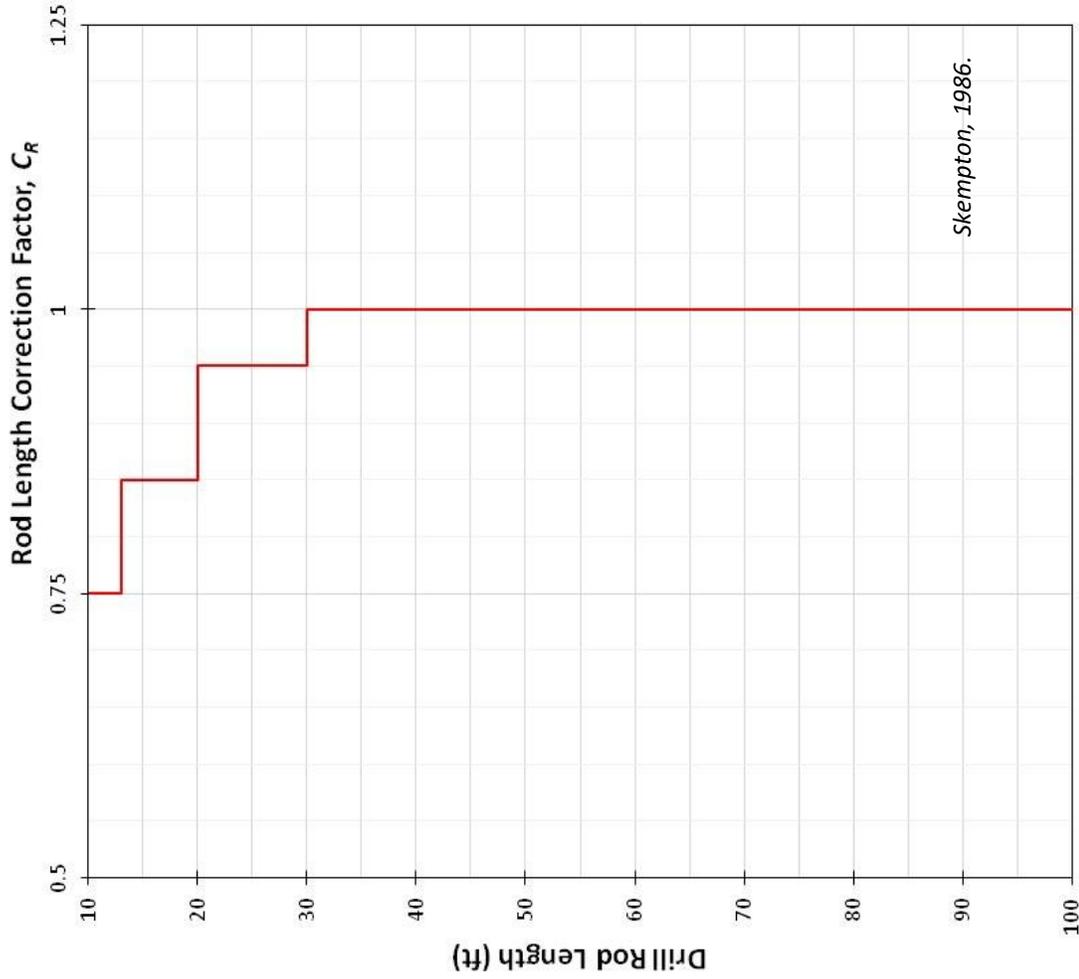
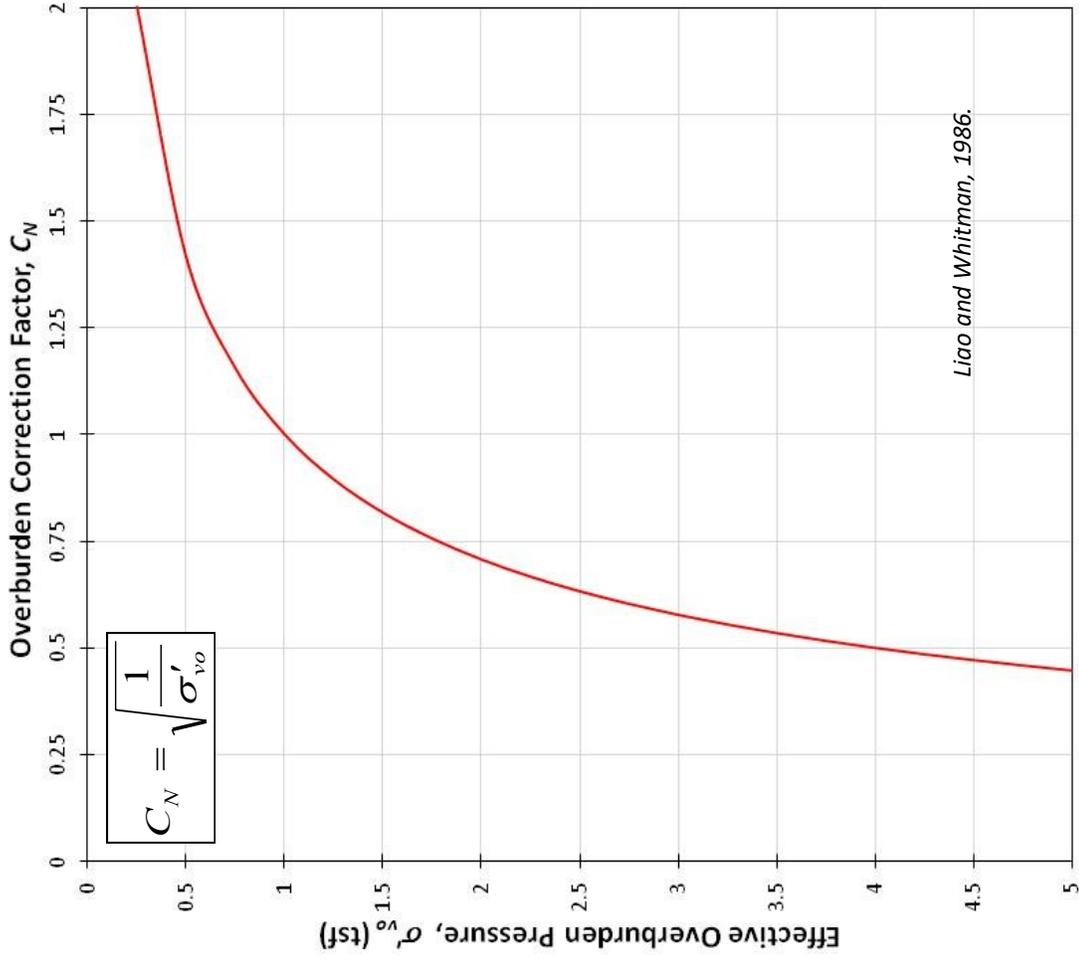
FIGURE NUMBER:
 4

- OVERBURDEN CORRECTION FACTOR IS USED ONLY FOR COHESIONLESS SOILS
- C_N IS THE RATIO OF THE MEASURED BLOW COUNT TO WHAT THE BLOW COUNT WOULD BE AT AN OVERBURDEN PRESSURE OF 1 TON/FT²
- Σ'_{v0} IS THE EFFECTIVE OVERBURDEN PRESSURE AT THE POINT OF MEASUREMENT (TON/FT²)

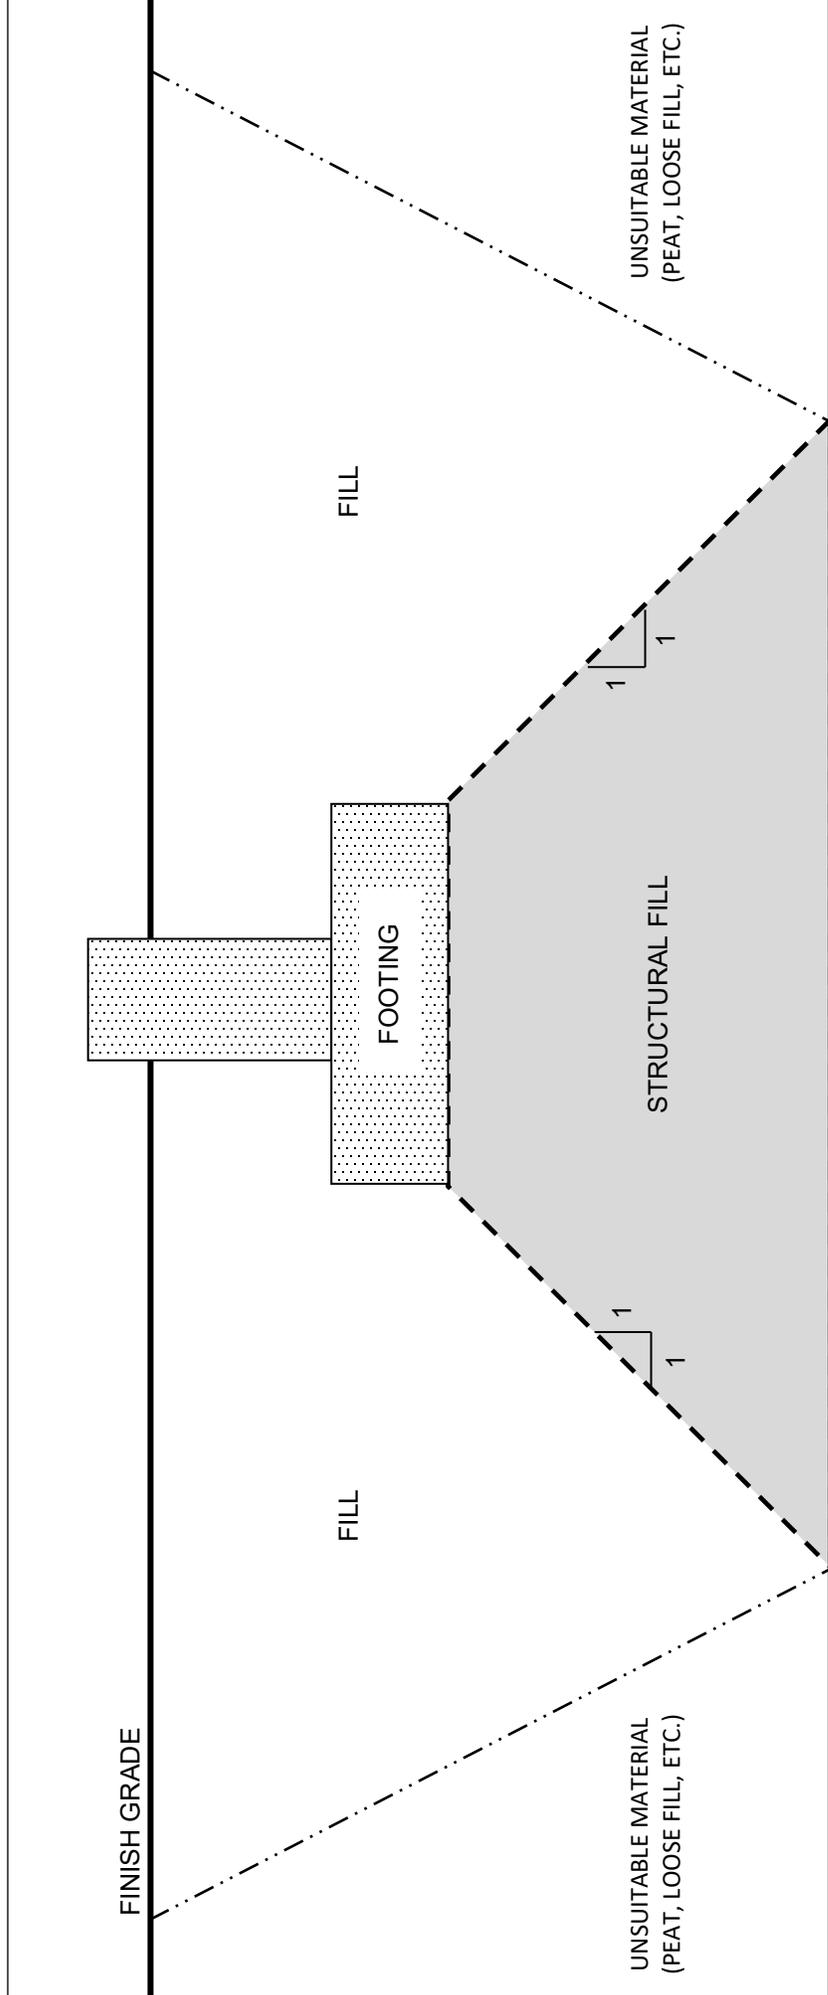
FIGURE NUMBER:
5

UNDISTURBED DENSE MINERAL SOILS

- Foundations should be placed on recommended bearing materials.
 - Recommended bearing materials: undisturbed native sand and gravel or properly compacted structural fill above the undisturbed native sand and gravel.
- Excavations into soils consisting of fill material that are backfilled with structural fill for any shallow foundations should be completed per Figure 5 of this report.

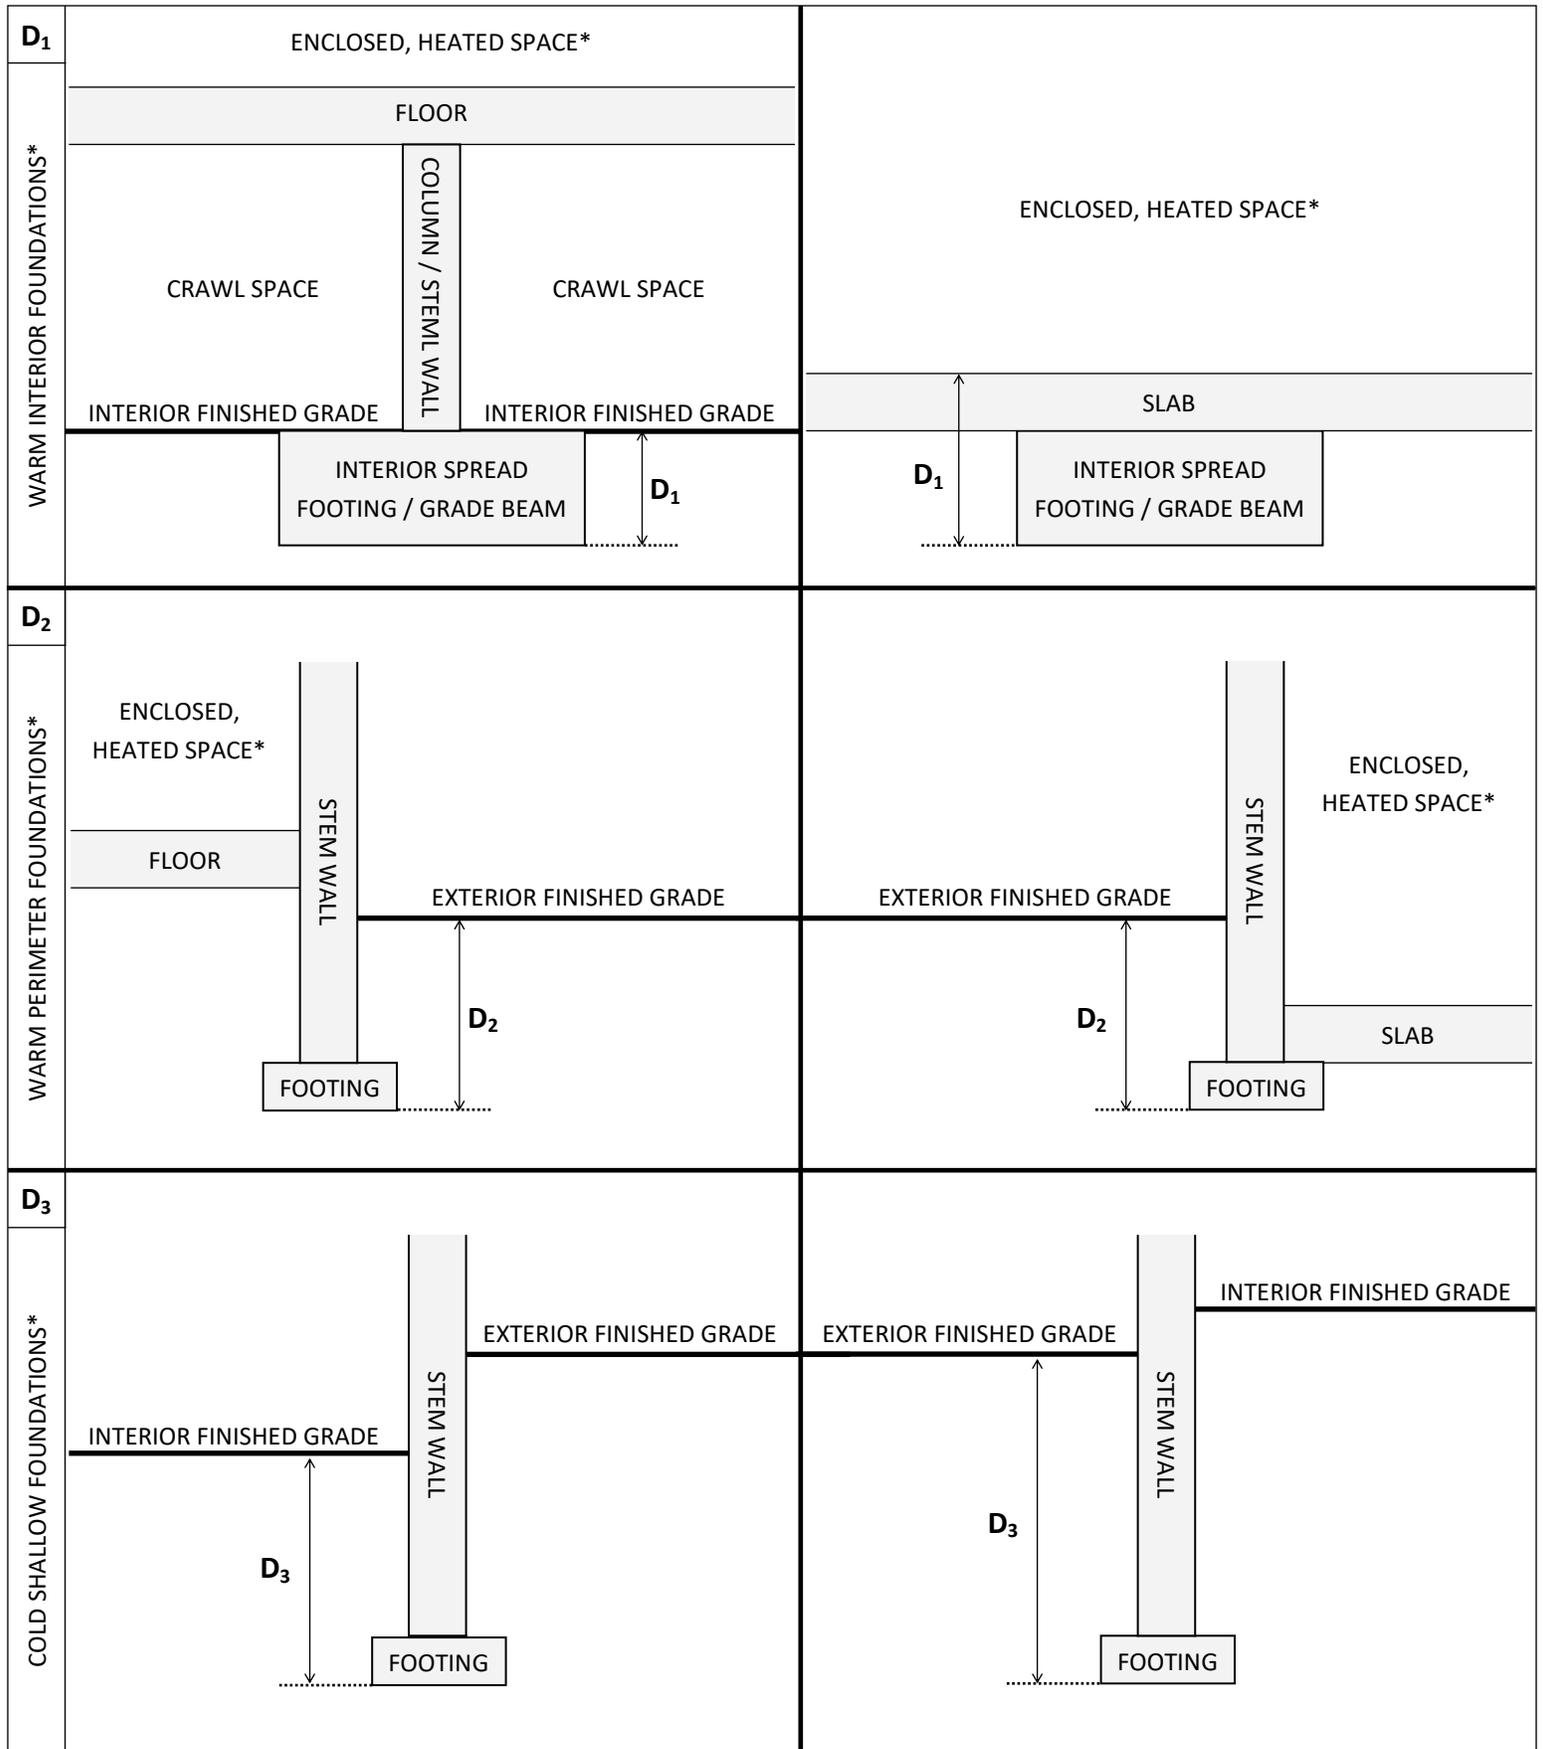
NOTES:
 DRAWINGS NOT TO SCALE
 MINIMUM DEPTHS PROVIDED IN REPORT

* ENCLOSED HEATED SPACES MUST BE CONTINUOUSLY MAINTAINED AT/ABOVE 40°F

<p>THICKENED EDGE SLAB</p> <p>SOILS PREPARED AS DESCRIBED IN TEXT</p> <p>NOTE: IF INSULATION IS PLACED UNDER SLAB USE CONFIGURATION D. T_E MINIMUM = 2".</p> <p>CONFIGURATION B</p>	<p>THICKENED EDGE SLAB</p> <p>SOILS PREPARED AS DESCRIBED IN TEXT</p> <p>NOTE: INSULATION OPTIONAL TO REDUCE DEPTH OF NFS FILL AT A RATE OF 1" INSULATION TO 12" NFS FILL. T_F MIN. = 1"</p> <p>CONFIGURATION F</p>
<p>*HEATED FOUNDATION TEMPERATURE MUST BE CONTINUOUSLY MAINTAINED AT/ABOVE 40°F</p> <p>**FLOOR SYSTEM CAN BE STRUCTURAL (W/ CRAWLSPACE) OR SLAB-ON-GRADE</p> <p>▨ = RIGID BOARD INSULATION</p> <p>DRAWING NOT TO SCALE</p>	
<p>NORTHERN GEOTECHNICAL ENGINEERING, INC.</p> <p>TERRA FIRMA TESTING</p> <p>FIGURE TITLE: INSULATED SHALLOW FOUNDATION CONFIGURATIONS</p> <p>PROJECT NAME: CIHA AIRPORT HEIGHTS SENIOR HOUSING PHASE 1</p> <p>PROJECT LOCATION: ANCHORAGE, ALASKA</p> <p>PROJECT ID: 10155-25</p> <p>FIGURE NUMBER: 7</p>

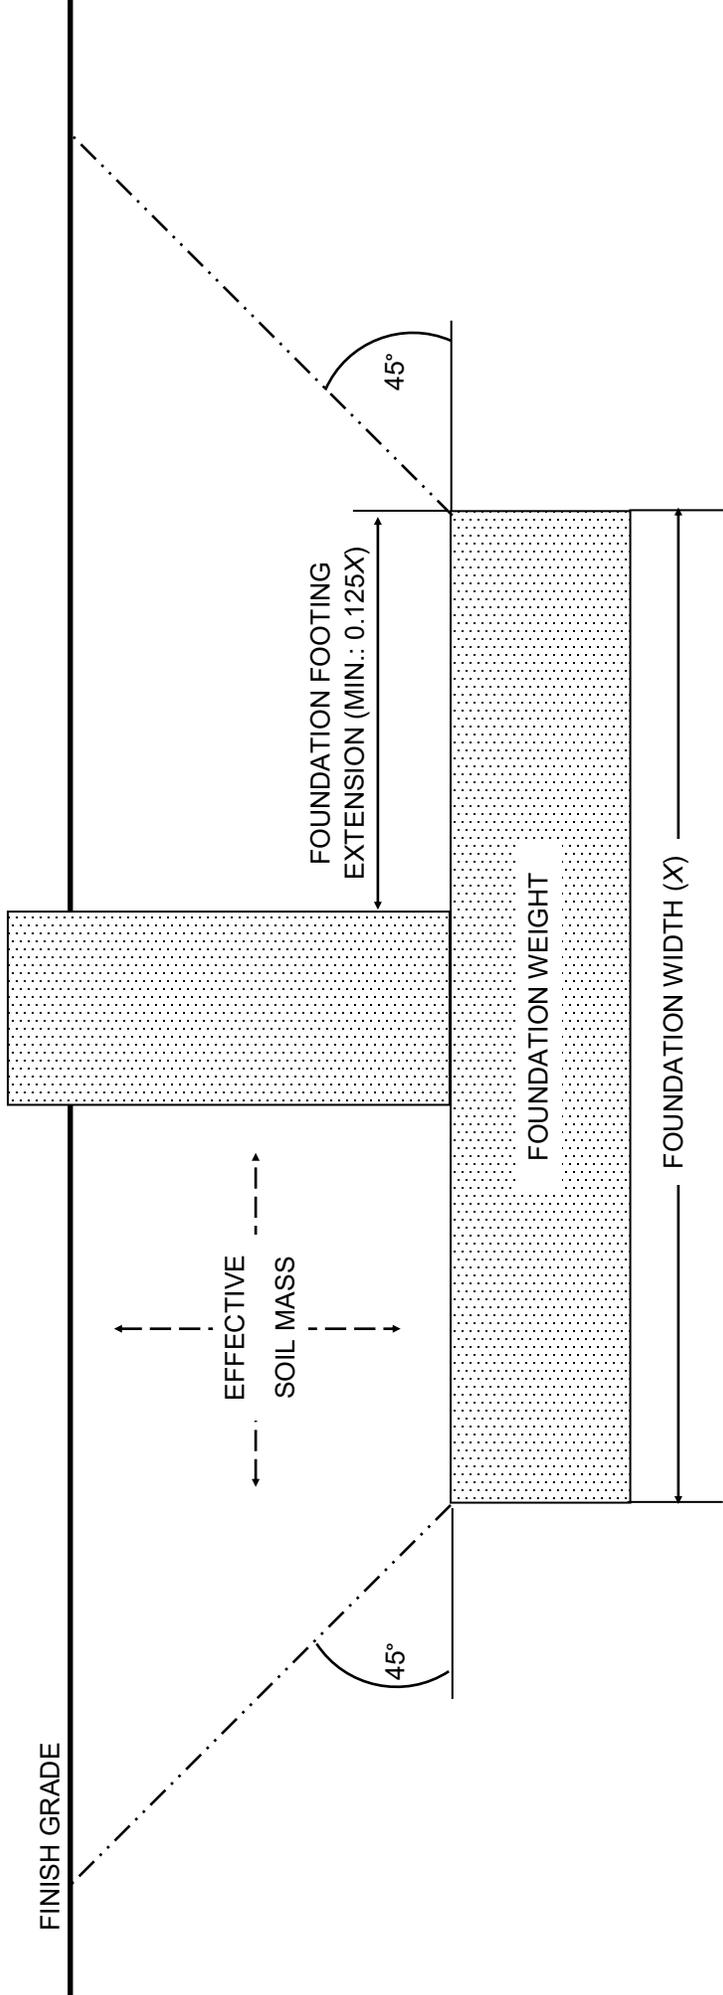
NORTHERN GEOTECHNICAL ENGINEERING, INC. TERRA FIRMA TESTING	
	FIGURE TITLE: FOOTING UPLIFT CAPACITY DIAGRAM	PROJECT NAME: CIHA AIRPORT HEIGHTS SENIOR HOUSING PHASE 1
	PROJECT ID: 10155-25	PROJECT LOCATION: ANCHORAGE, ALASKA
	FIGURE NUMBER: 8

UPLIFT CAPACITY = $0.8 \times$ (EFFECTIVE SOIL WEIGHT + WEIGHT OF FOUNDATION)

= FOOTING / STEM WALL

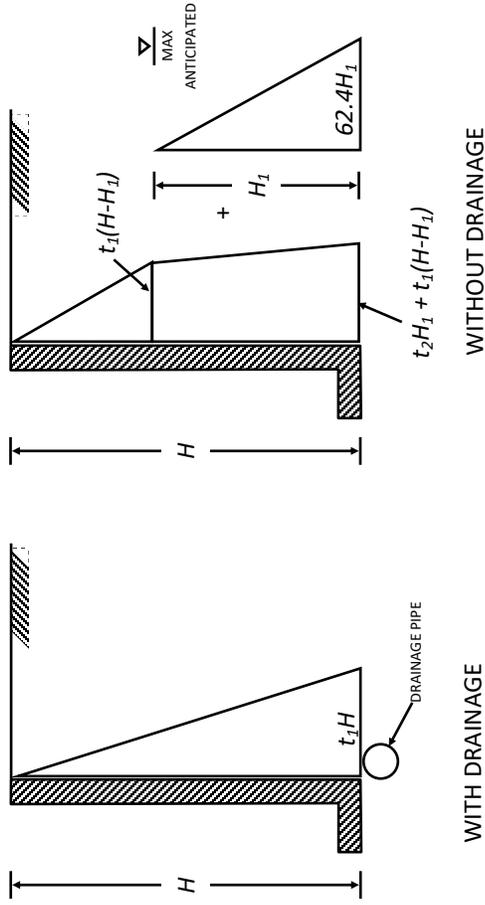
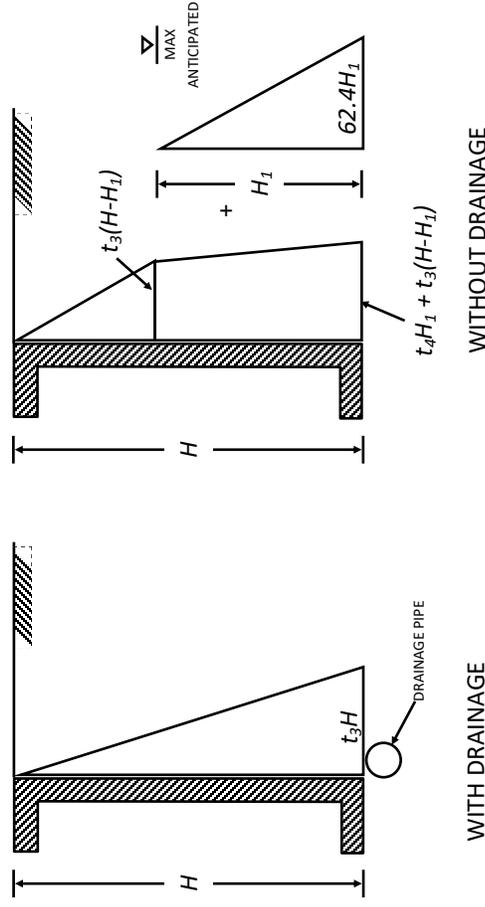
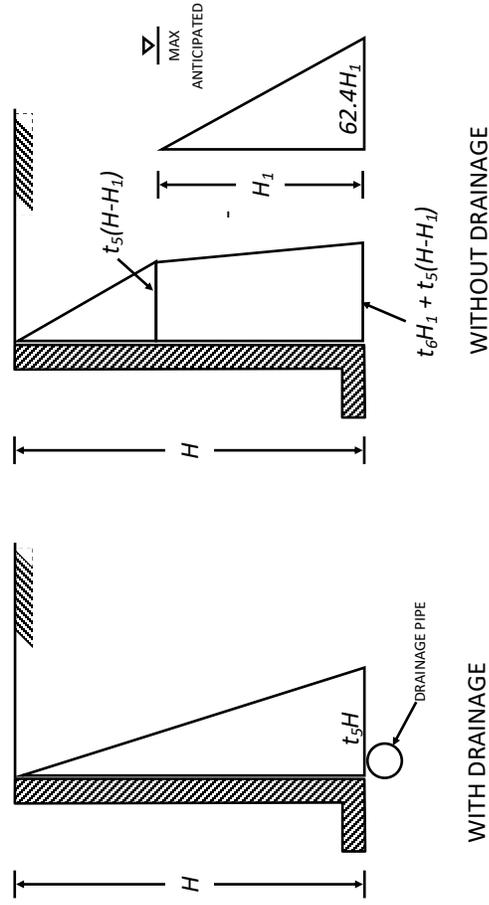
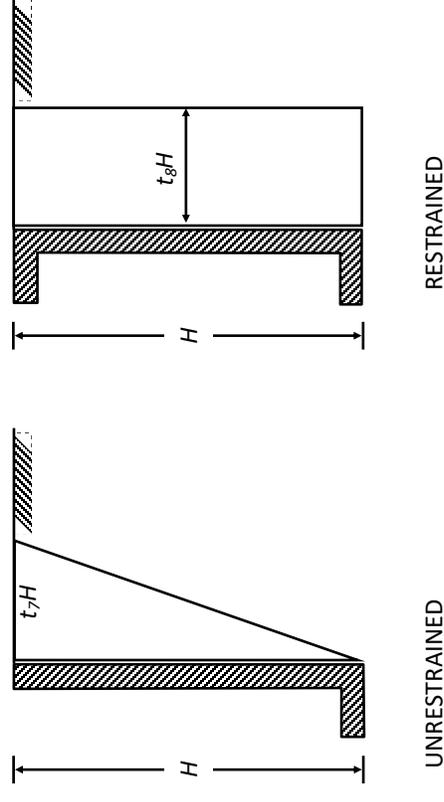
ACTIVE PRESSURE CONDITION

AT-REST PRESSURE CONDITION

PASSIVE PRESSURE CONDITION

SEISMIC

NOTE: WALLS CAN BE EITHER FREE OR RESTRAINED AT THE TOP FOR THE PASSIVE PRESSURE CONDITION. EQUATIONS ARE ONLY VALID FOR UNITS OF t_{1-8} (PCF) AND $H-H_1$ (FT).

NOTE: SEISMIC LOADS ARE VALID FOR WALLS RETAINING LESS THAN 8 FEET VERTICAL OF EARTH. THE SEISMIC LOAD IS ADDED TO ACTIVE OR AT-REST CONDITIONS AND IS SUBTRACTED FROM PASSIVE CONDITIONS.

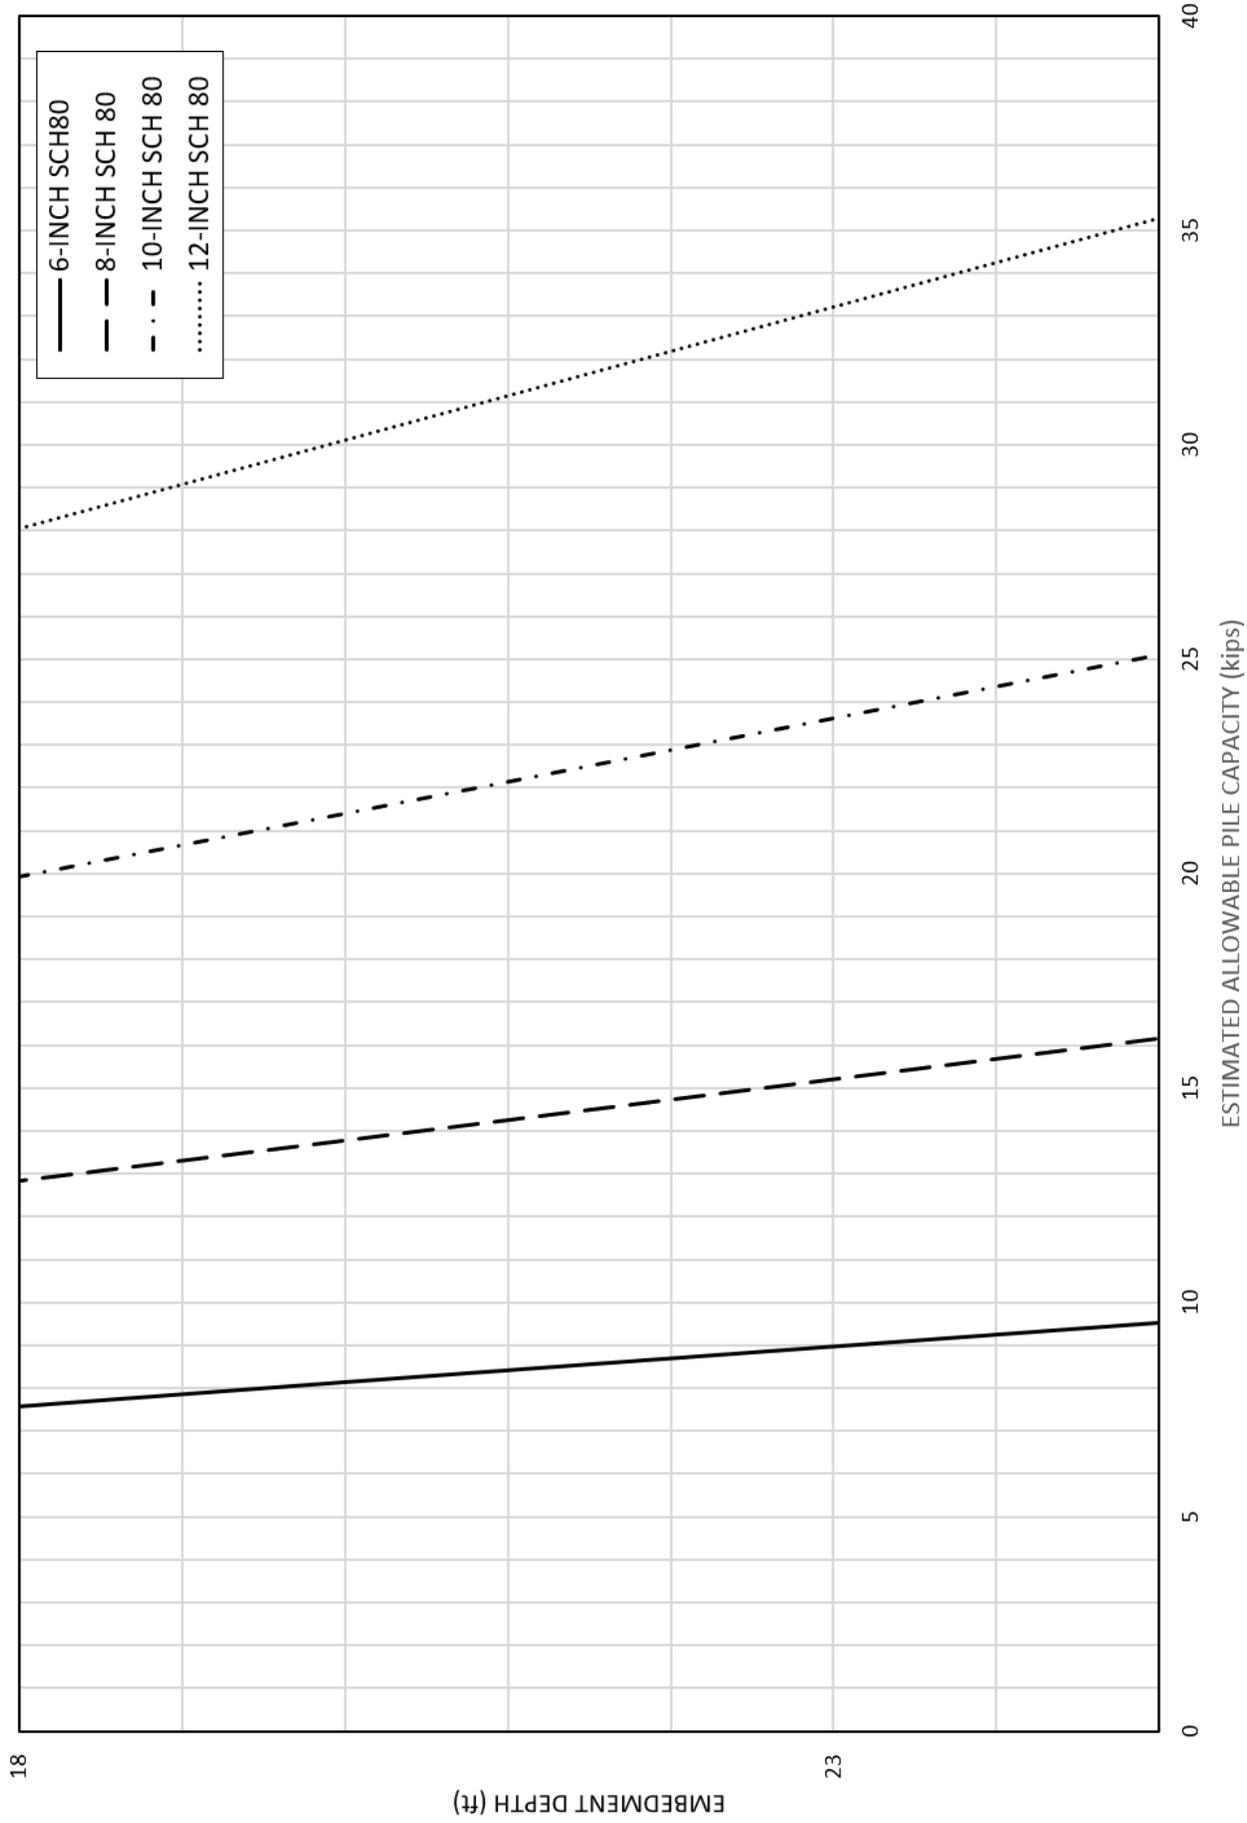
FIGURE TITLE: ESTIMATED ALLOWABLE PILE CAPACITY VS EMBEDMENT DEPTH
 PROJECT NAME: CIHA AIRPORT HEIGHTS SENIOR HOUSING PHASE 1
 PROJECT LOCATION: ANCHORAGE, ALASKA

ESTIMATED ALLOWABLE PILE CAPACITY VS EMBEDMENT DEPTH

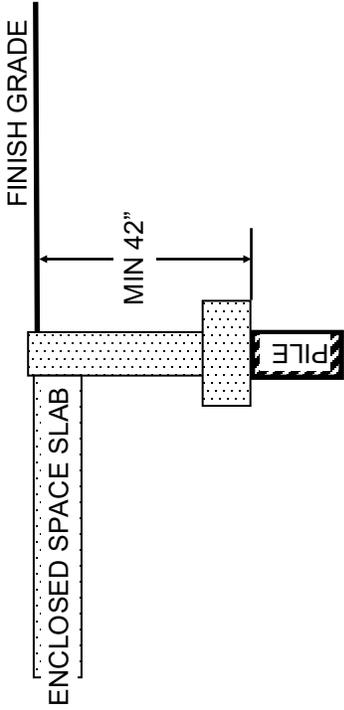
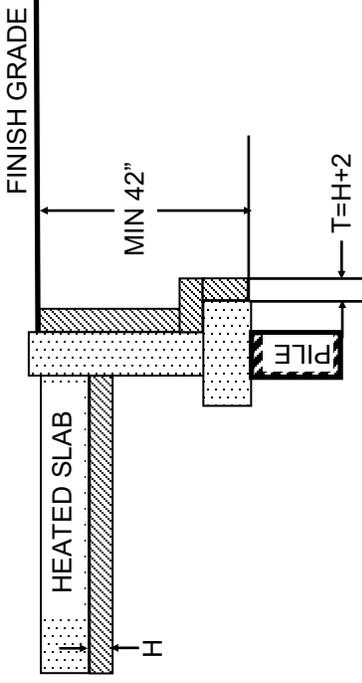
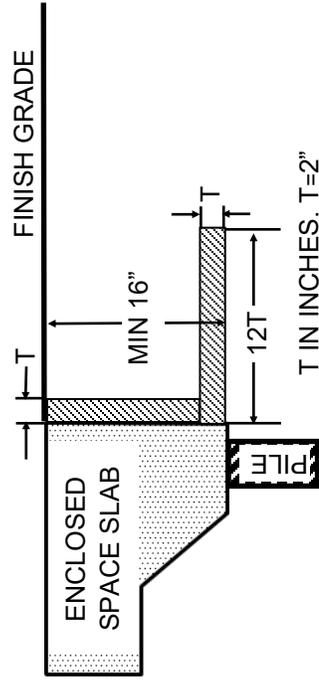
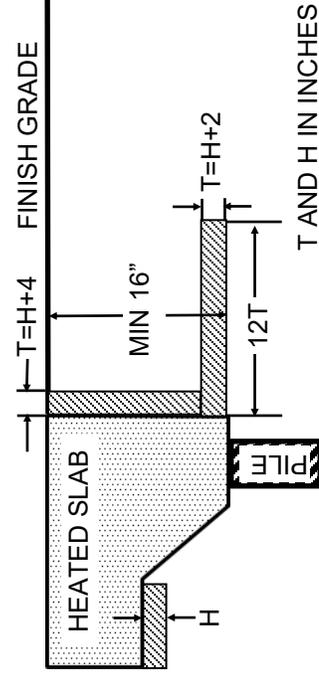
ENCLOSED (HEATED) SPACE SLAB

SLABS MUST BE STRUCTURAL OR SEPERATED FROM GRADE BEAM

NOTE: IF INSULATION IS PLACED UNDER SLAB USE
CONFIGURATION B

HEATED (RADIANT) SLAB

NOTE: DO NOT INSULATE FOOTING SURFACES BELOW SLAB
THE THICKNESS OF INSULATION "H" CAN BE CHANGED
TO OBTAIN DESIRED INSULATION BENEATH SLAB

SLAB ON GRADE

T IN INCHES. T=2"

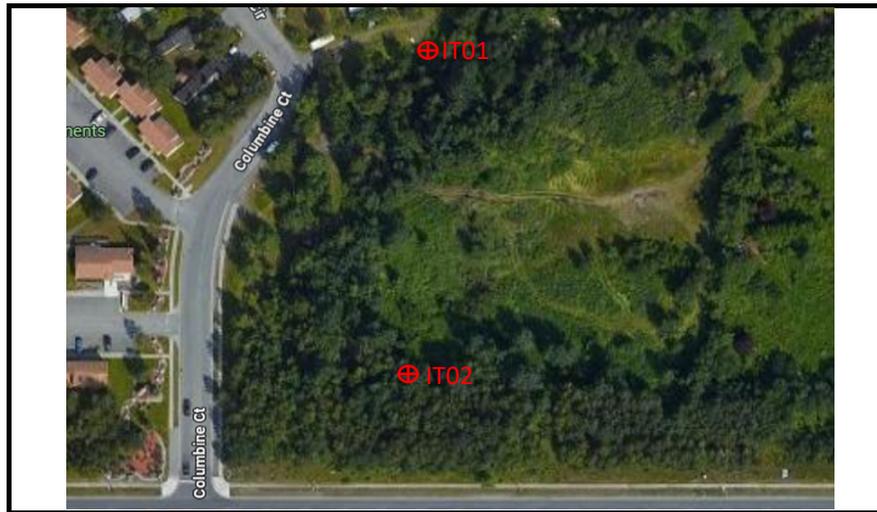
Site Plan

Depth (feet) (USCS)	
1	(SM)
2	
3	
4	
5	
6	(SW)
7	
8	
9	
10	
11	
12	
13	
14	
15	
16	
17	
18	
19	
20	
21	
22	
23	
24	
25

Was GW Observed ATD? No GW Monitoring Depth N/E bgs
 If yes, at what depth? ... Date of Measurement 10/3/25

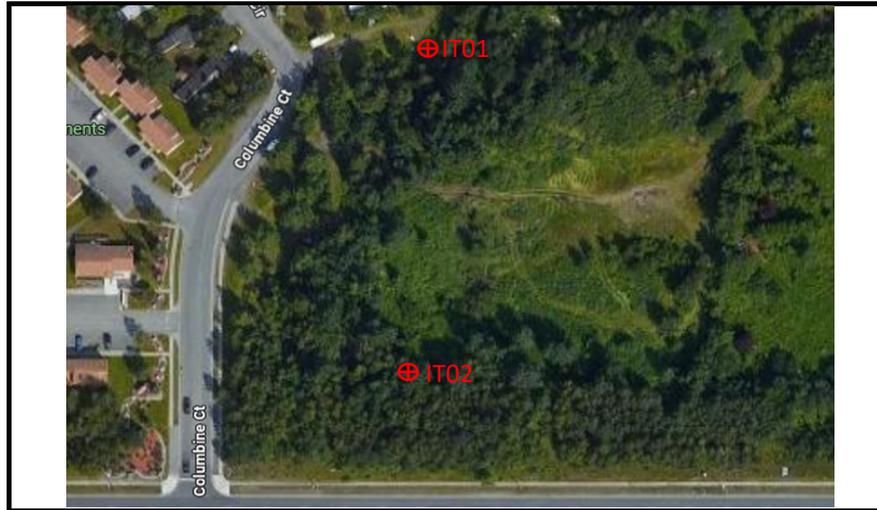
Site Plan

Depth (feet) (USCS)	(GM)
1	
2	
3	
4	
5	
6	
7	
8	BOH
9	
10	
11	
12	
13	
14	
15	
16	
17	
18	
19	
20	
21	
22	
23	
24	
25

Was GW Observed ATD? Yes GW Monitoring Depth 10.98 ft bgs
 If yes, at what depth? ~ 11 ft bgs Date of Measurement 10/3/25

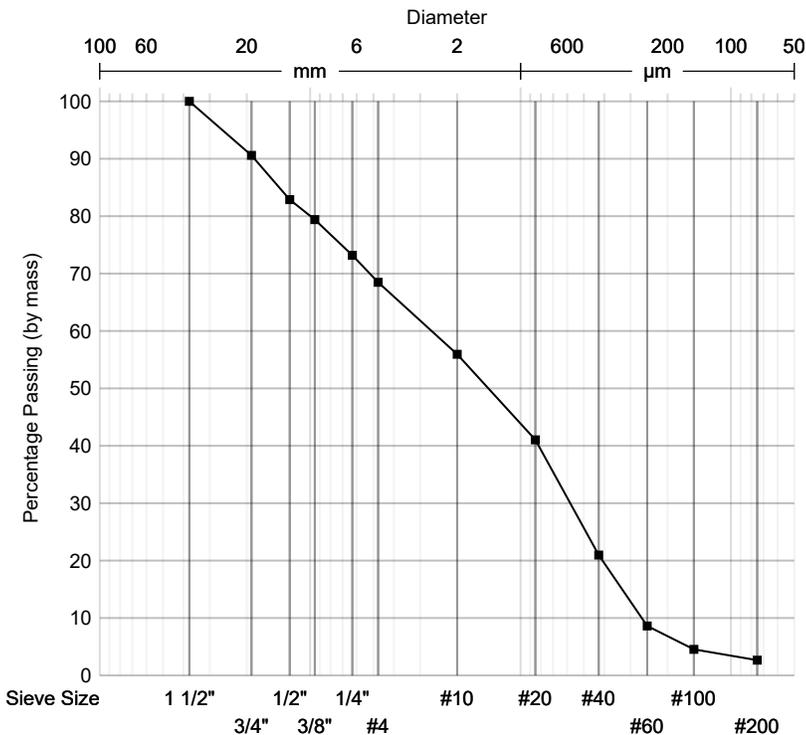
Sieve Size	% Passing	Limits
1 1/2in	100	
3/4in	91	
1/2in	83	
3/8in	79	
1/4in	73	
No.4	68	
No.10	56	
No.20	41	
No.40	21	
No.60	9	
No.100	5	
No.200	2.7

COBBLES	GRAVEL (32%)		SAND (66%)			SILT/CLAY
	COARSE	FINE	COARSE	MEDIUM	FINE	
0%	9.4%	22.1%	12.5%	35.0%	18.3%	3%
