**TRACT 1, NORTHWAY BUSINESS PARK SEWARD TOWERS  
ANCHORAGE, ALASKA**

**PHASE I ENVIRONMENTAL SITE ASSESSMENT**

**NOVEMBER 2024**

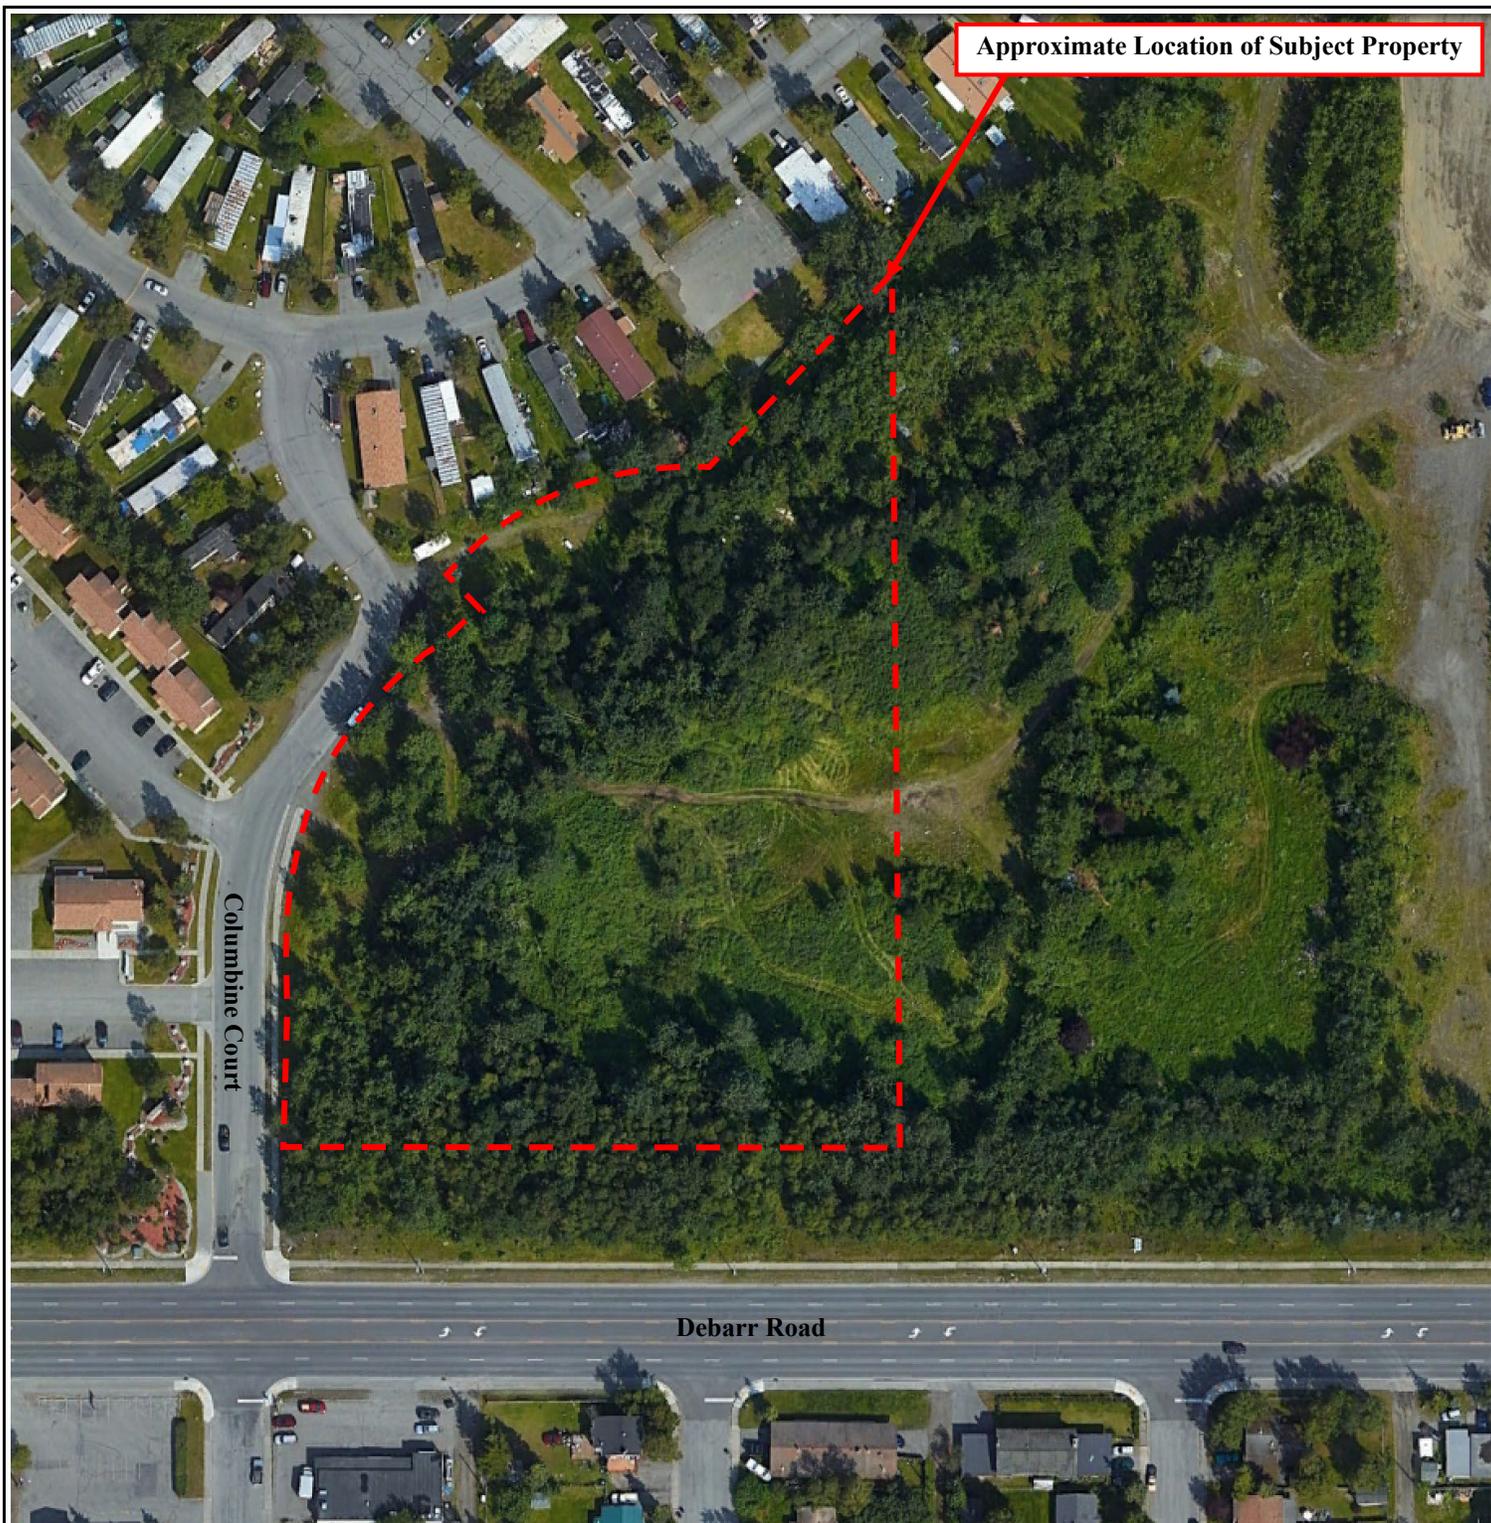
Figure 5

The August 31, 2002 aerial photograph, included as Figure 5, showed the subject property as being covered with vegetation. The remnants of vehicle trails were present in the central portion of the lot, and some indiscernible debris was present in the northern “point” of the property. The surrounding properties and roadways were similar to their appearances in the 1990 aerial photograph.

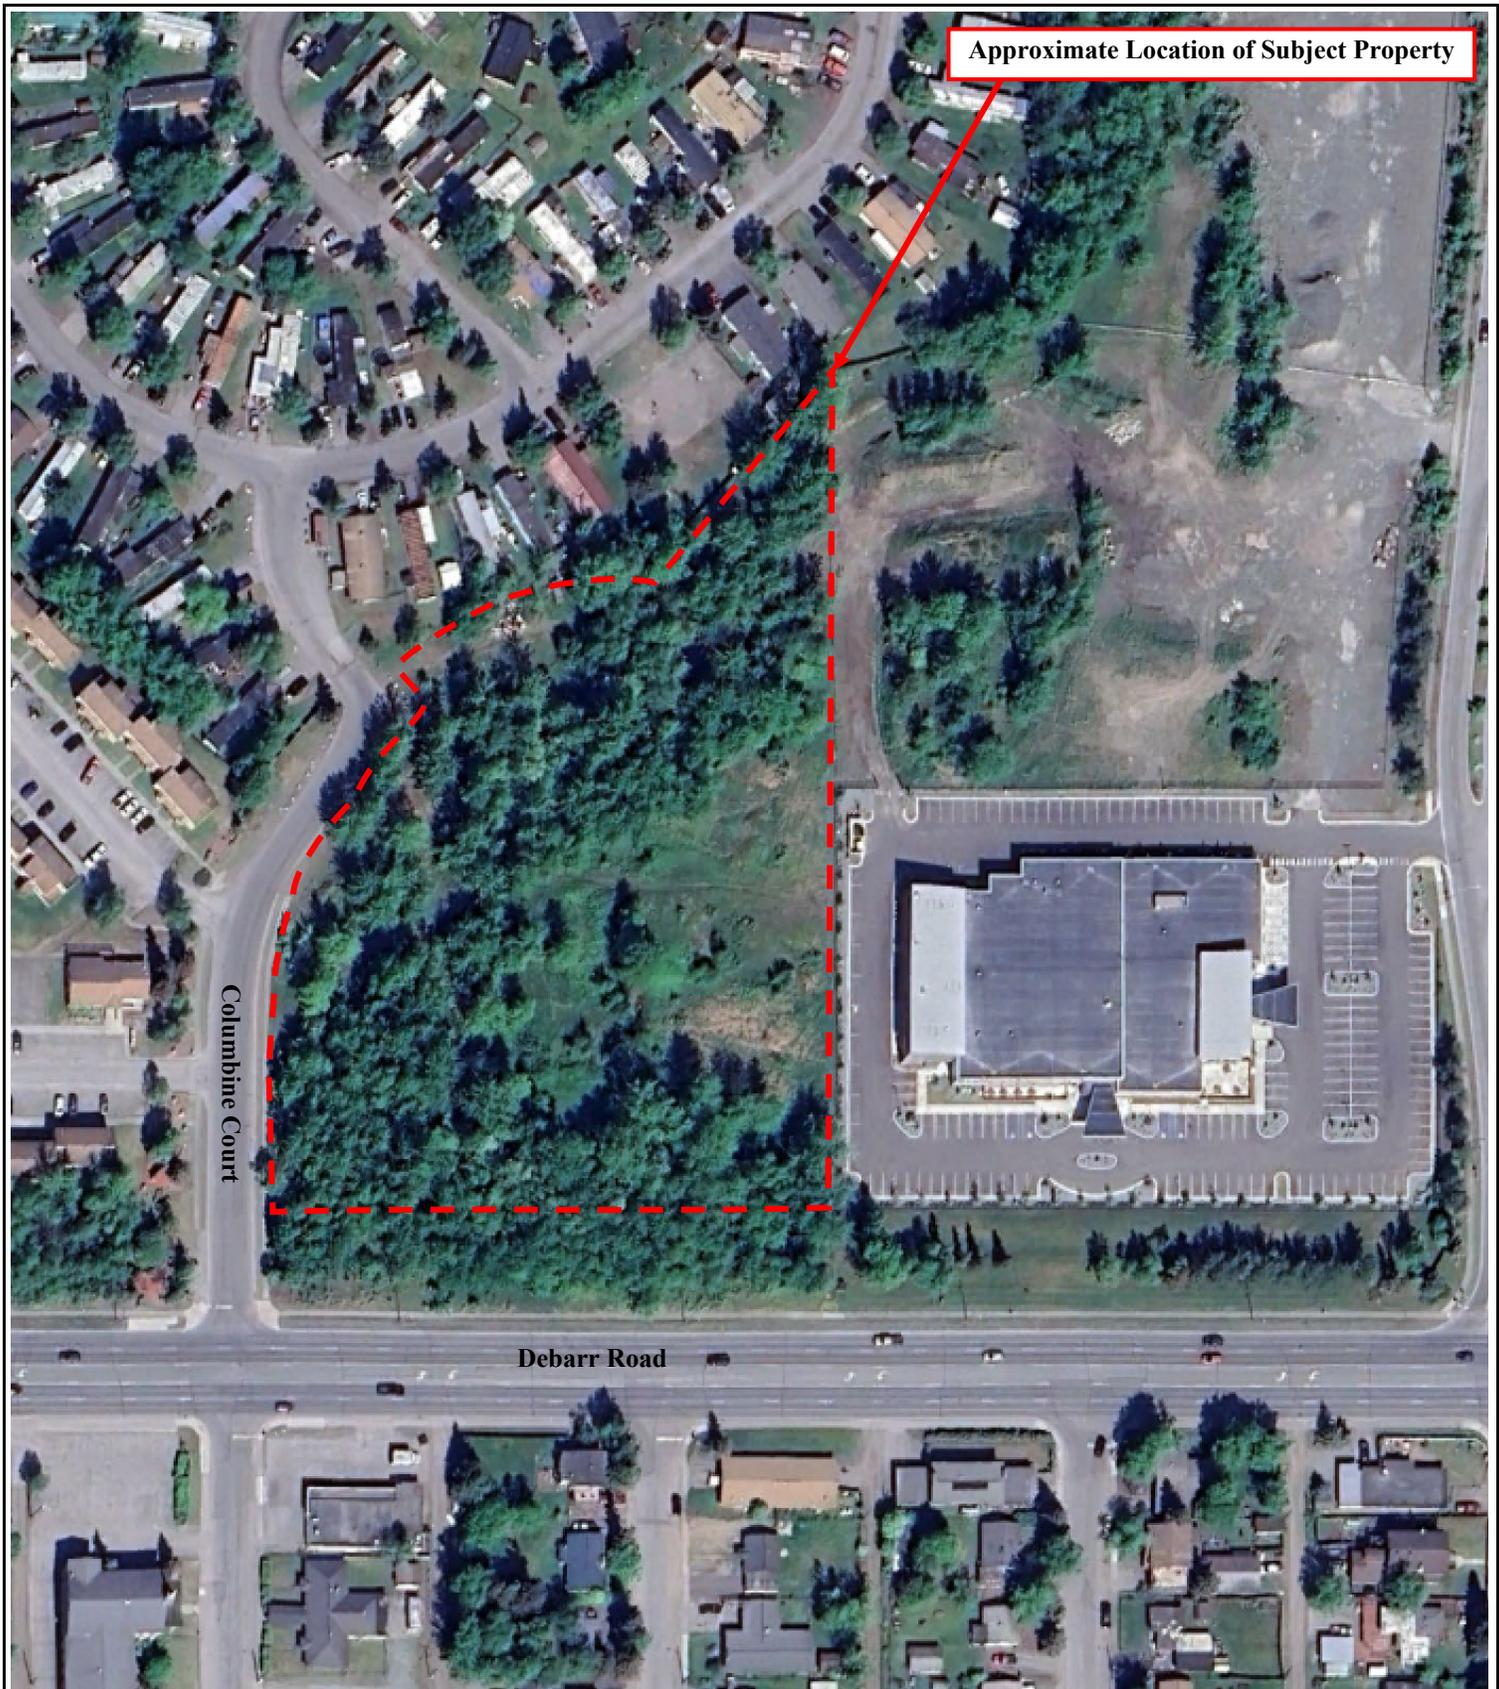
Figure 6

The July 1, 2014 aerial photograph, included as Figure 6, showed the subject property as being similar in appearance to what was observed in the 2002 aerial photograph. What may have been remnants of homeless camps were visible among the trees in the northern portion of the property. The surrounding properties were also similar in appearance to how they looked in the 2002 aerial photograph.

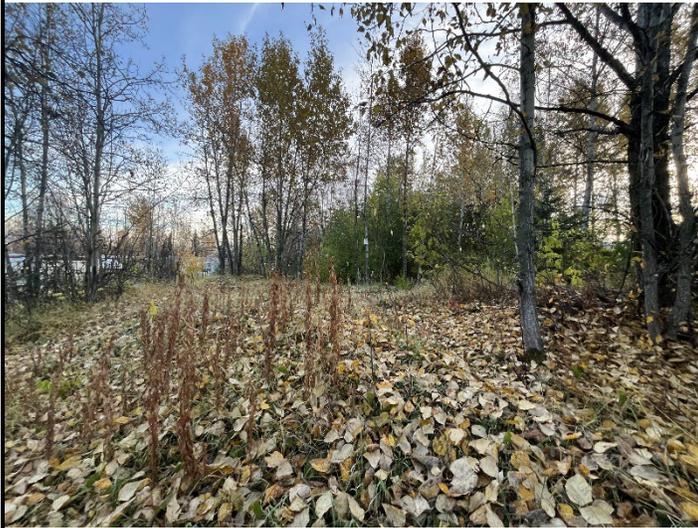
The subject property was accessed from Debarr Road and consisted of an undeveloped lot that was bordered by sidewalks along the south and west sides, a hospital to the east end, a mobile home park to the northwest, and a cleared vacant lot to the northeast (Photographs 1 through 4 in Appendix B).

**Photo 1. Subject Property Vicinity (looking west)**

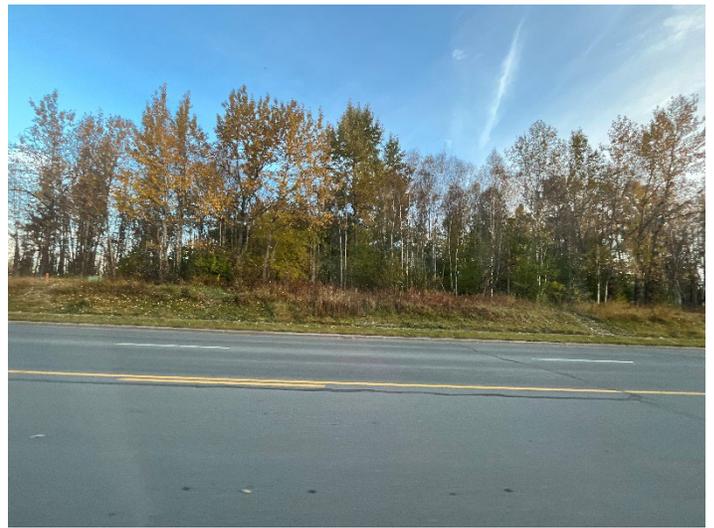
**Photo 2. Subject Property (looking north)**

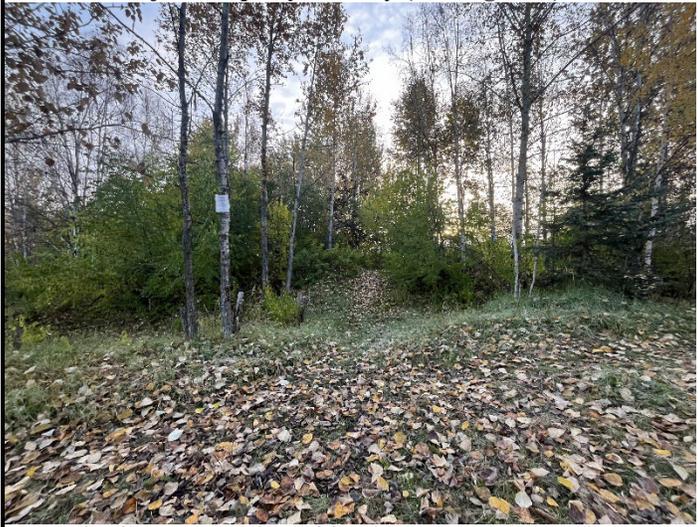
**Photo 3. Central Portion of Subject Property (looking NE)**

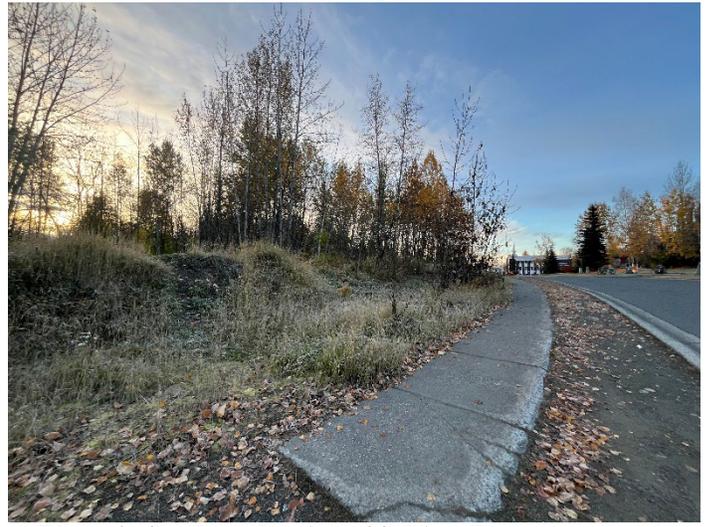
**Photo 4. Southern Portion of Subject Property**

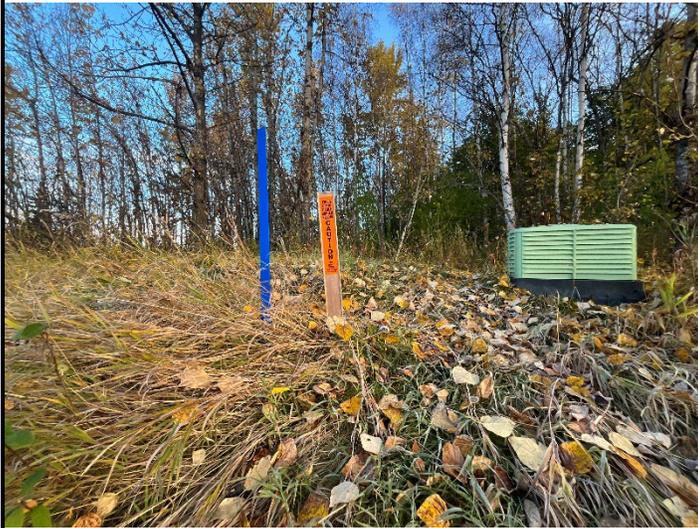
Miscellaneous debris and windblown trash were scattered across the subject property (Photographs 5 and 6 in Appendix B). The south side of the property contained a fiber optic cable box (Photograph 7 in Appendix B). The northwest portion of the subject property contained an area of open clearing (Photographs 8 and 9 in Appendix A).

Photo 7. Fiber Optic Cable Box

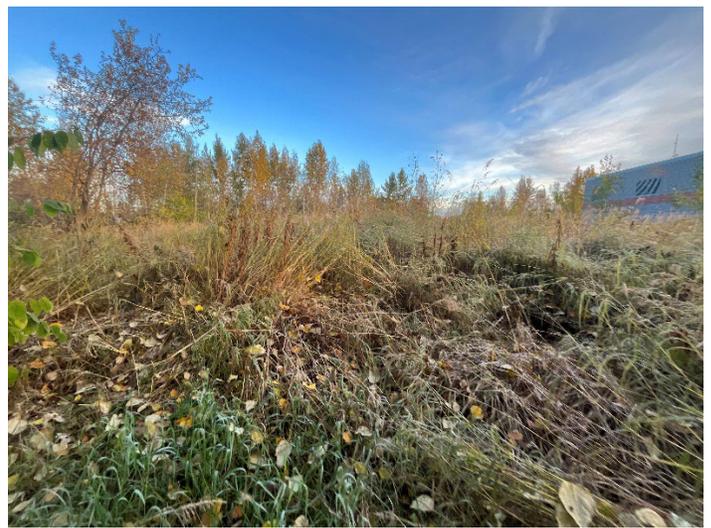
Photo 8. Northern Portion of Subject Property

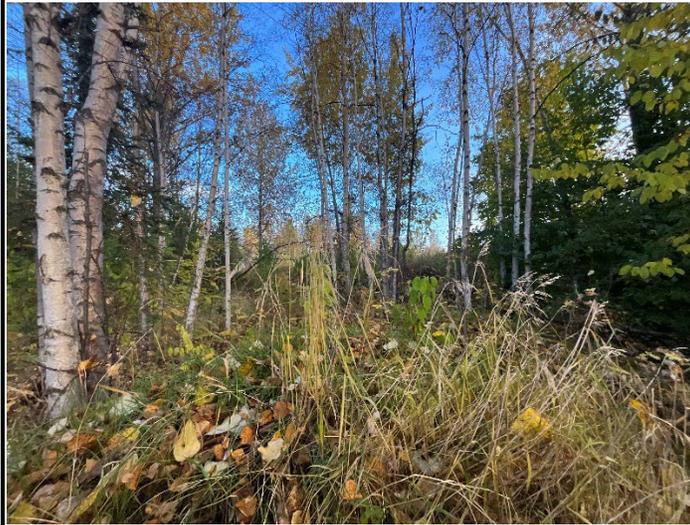
Photo 9. Northern Portion of Subject Property

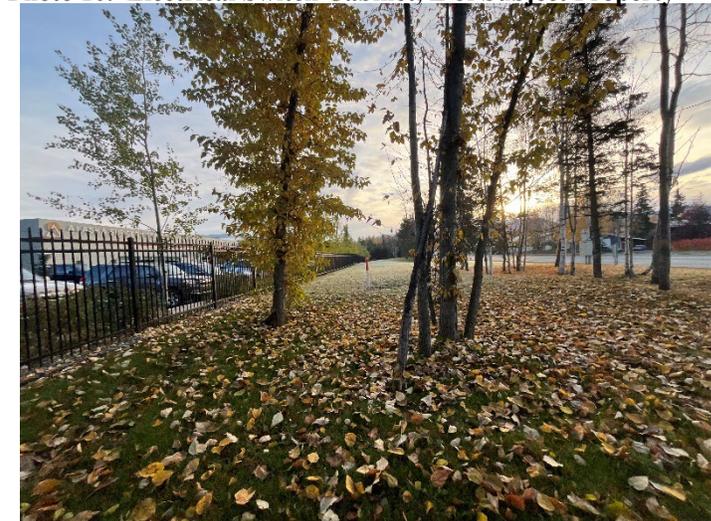
An electrical switch cabinet and a pad-mounted transformer were located just east of the southeast corner of the subject property (Photographs 10 and 11 in Appendix B). The transformer had what appeared to be a small leak on its cement pedestal. The transformer bore a 'No PCB's' sticker (Photograph 11 in Appendix B). A metal fence separated the subject property from the surgery center to the east (Photograph 12 in Appendix B).

Photo 12. Fence & Hospital Facility to East (looking S)

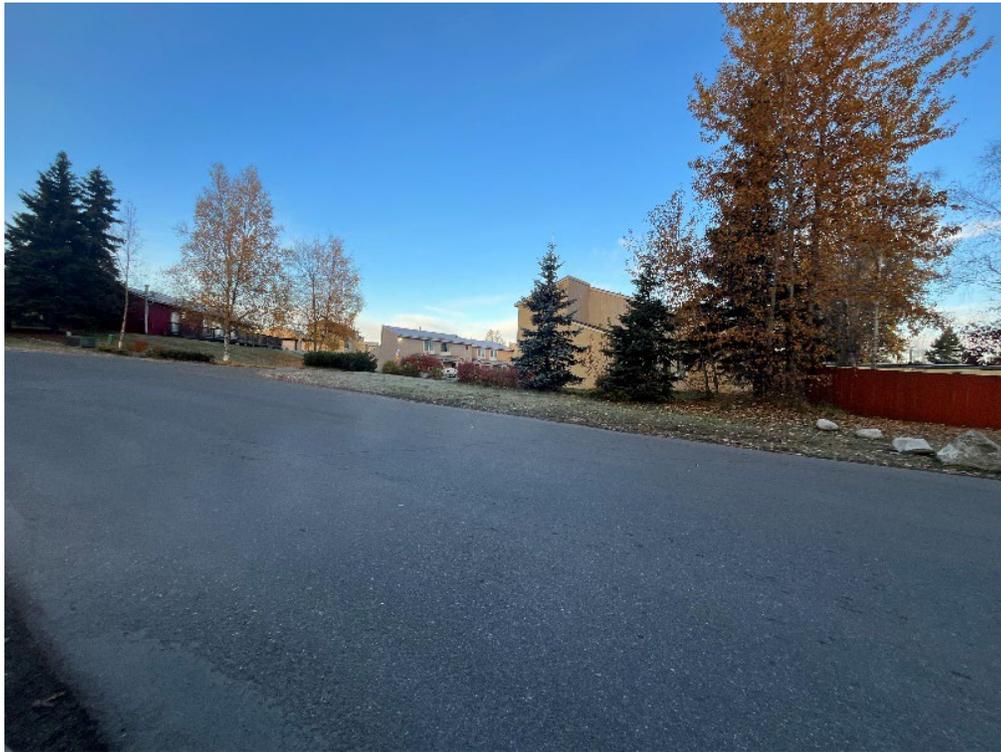
The area surrounding the subject property was comprised of the Alaska Surgery Center to the east, Debarr Road to the south, and Columbine Court to the west. There was a residential area and a mobile home park to the west and northwest of the subject property (Photographs 13 and 14 in Appendix B).

**Photo 13. Residential Area Adjacent to Subject Property (looking southwest)**

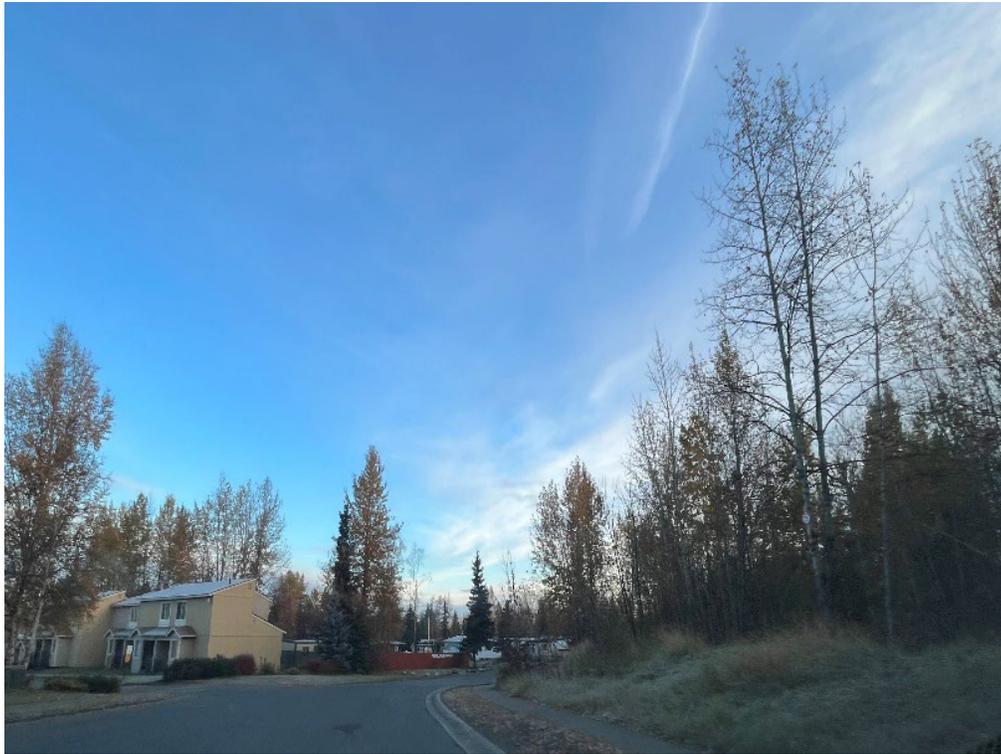
**Photo 14. View of Residential Area (facing north-northwest)**
