GEOTECHNICAL ENGINEERING REPORT

ACLT KITCHEN ANCHORAGE, ALASKA

NGE-TFT Project #7289-25

**RE: GEOTECHNICAL ENGINEERING ASSESSMENT FOR THE PROPOSED ACLT
KITCHEN LOCATED IN THE MOUNTAIN VIEW SUBDIVISION –
ANCHORAGE, ALASKA**

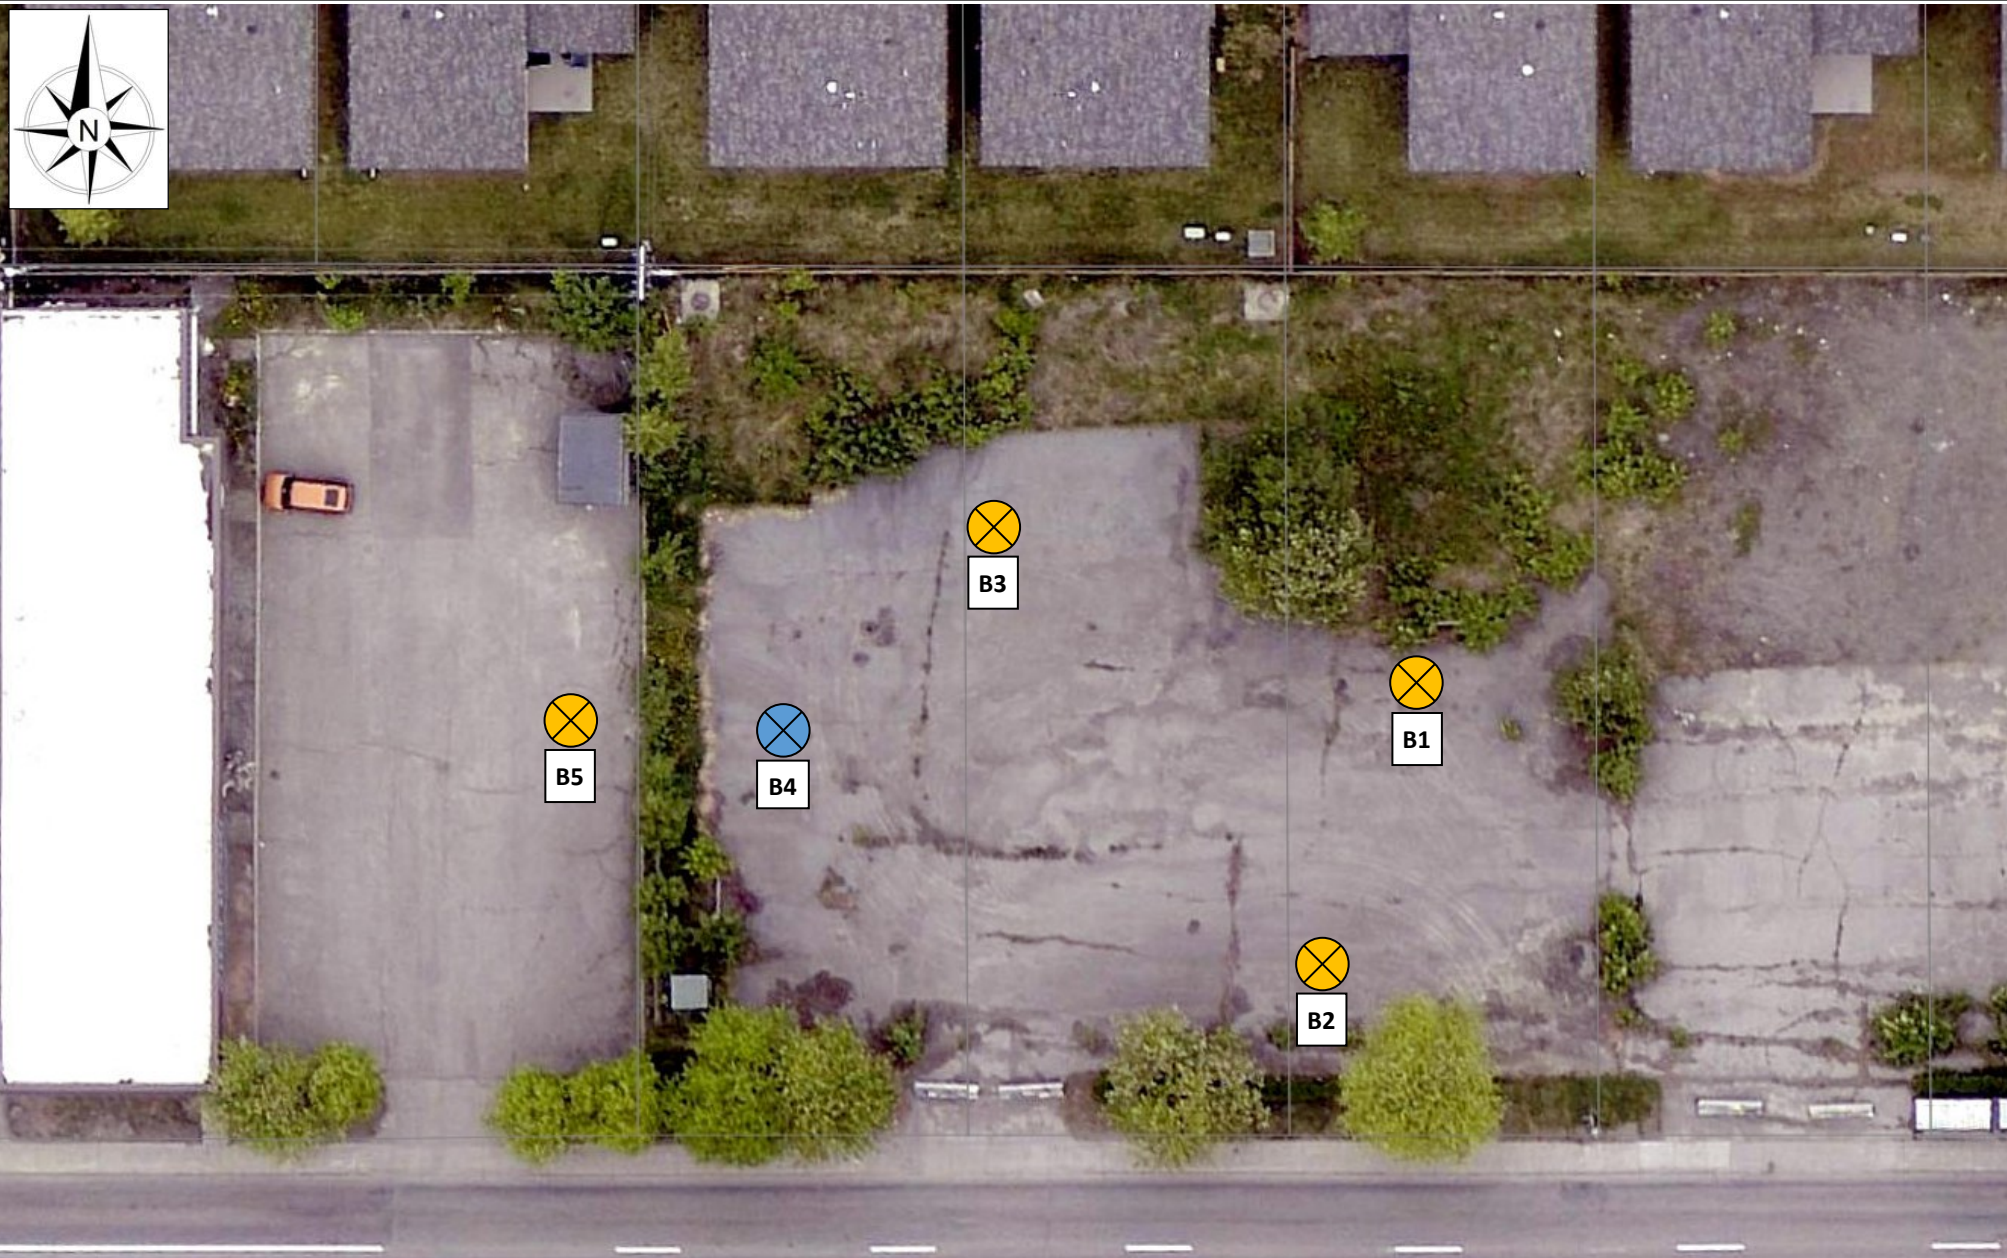
APPROXIMATE BOREHOLE EXPLORATION LOCATIONS:

Current Site Conditions: (Figure 2)

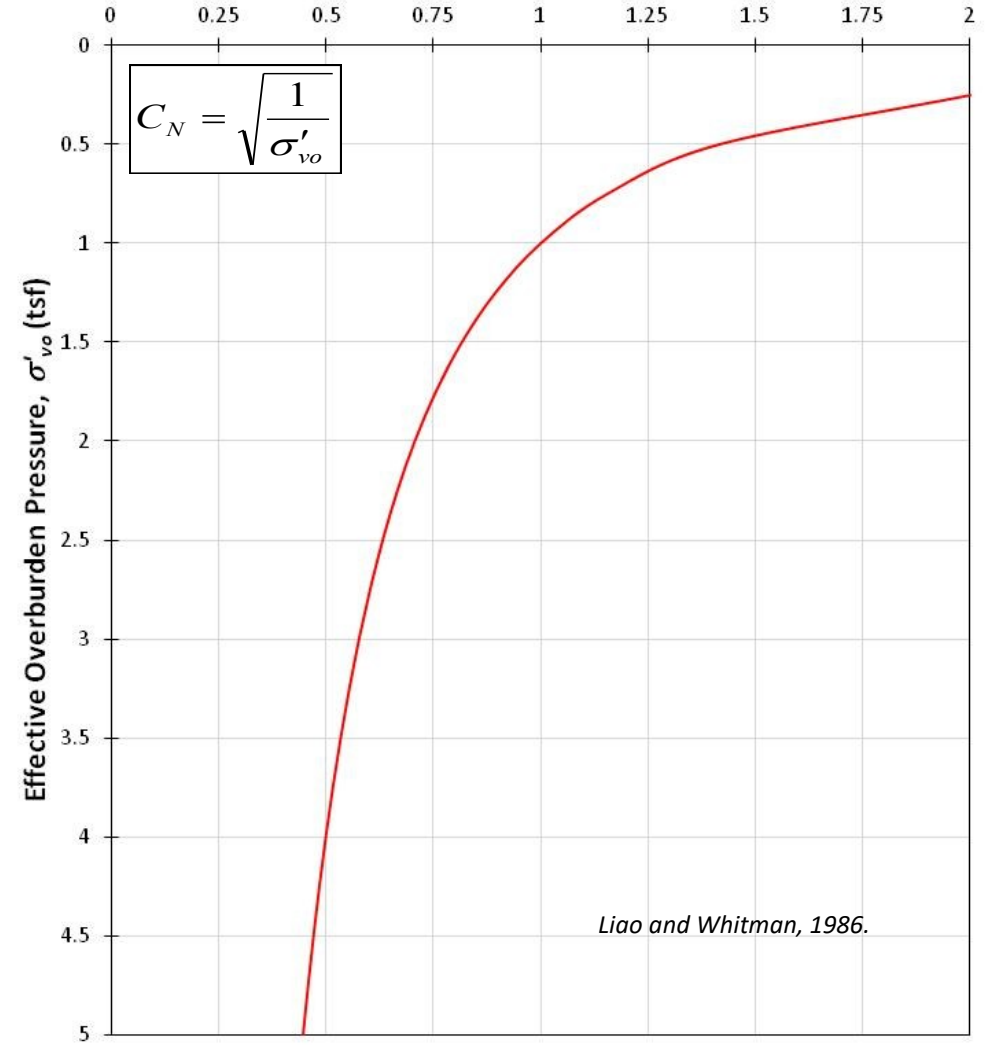
Overburden Correction Factor, C_N

- Overburden correction factor is used only for cohesionless soils
- C_N is the ratio of the measured blow count to what the blow count would be at an overburden pressure of 1 ton/ft²
- σ'_{vo} is the effective overburden pressure at the point of measurement (ton/ft²)

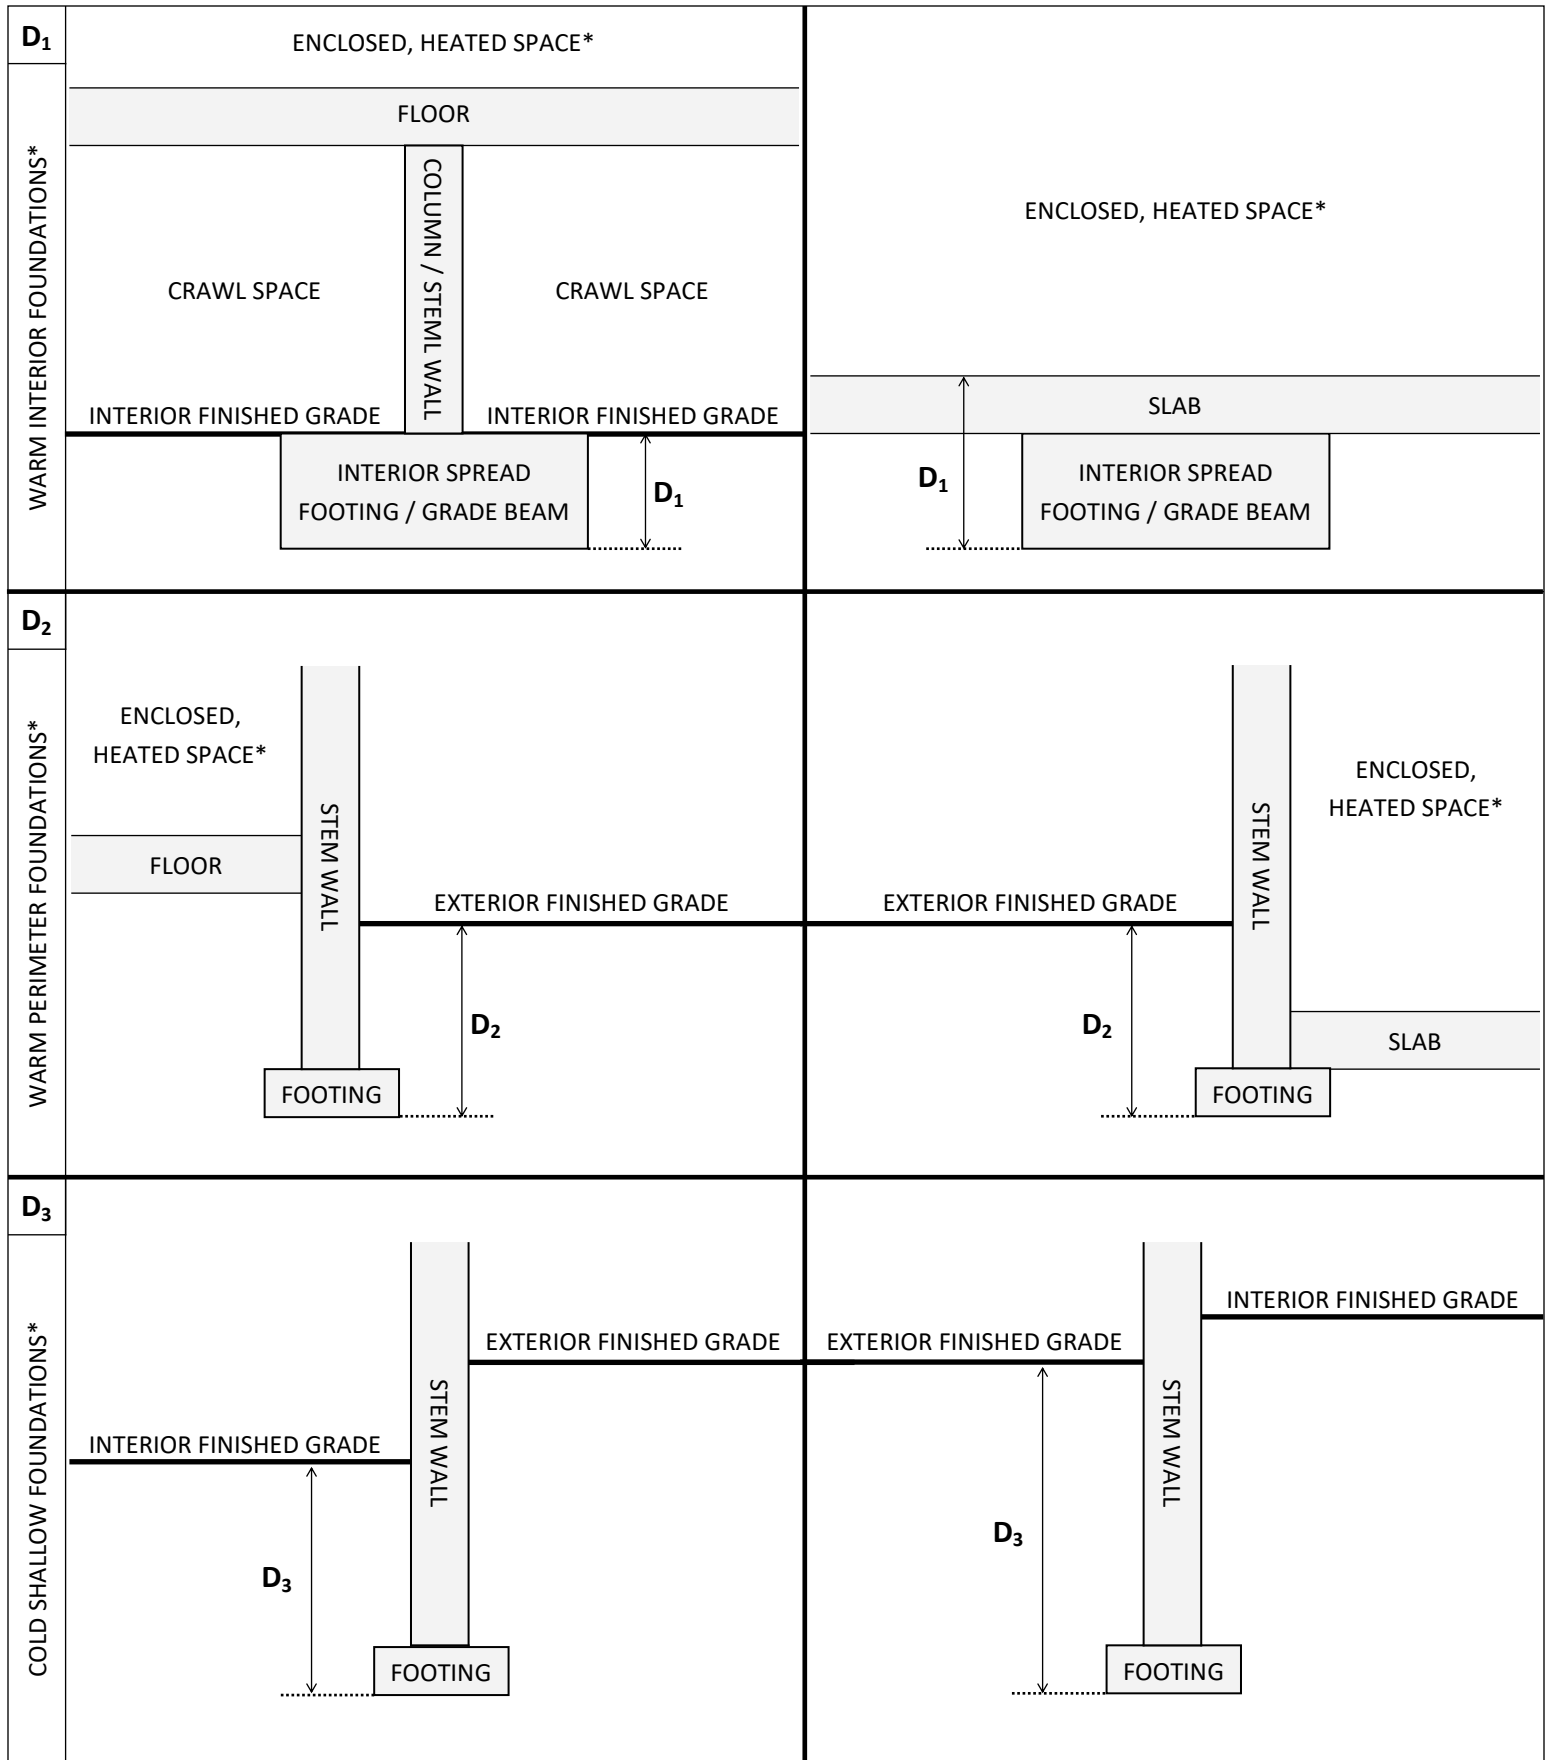
NOTES:
 DRAWINGS NOT TO SCALE
 MINIMUM DEPTHS PROVIDED IN REPORT

* ENCLOSED HEATED SPACES MUST BE CONTINUOUSLY MAINTAINED AT/ABOVE 40°F

For the project site, the minimum burial depth for any uninsulated shallow foundation footings should be as follows (measured from the bottom of the foundation footing):

1. 12 inches (D_1 in Figure 5) for interior footings located entirely within an enclosed, continuously heated space* (measured from the bottom of the footing to the top of the floor slab) and
2. 42 inches (D_2 in Figure 5) for foundation footings located along the perimeter of an enclosed, continuously heated space* (measured from the bottom of the footing to the exterior finished grade).

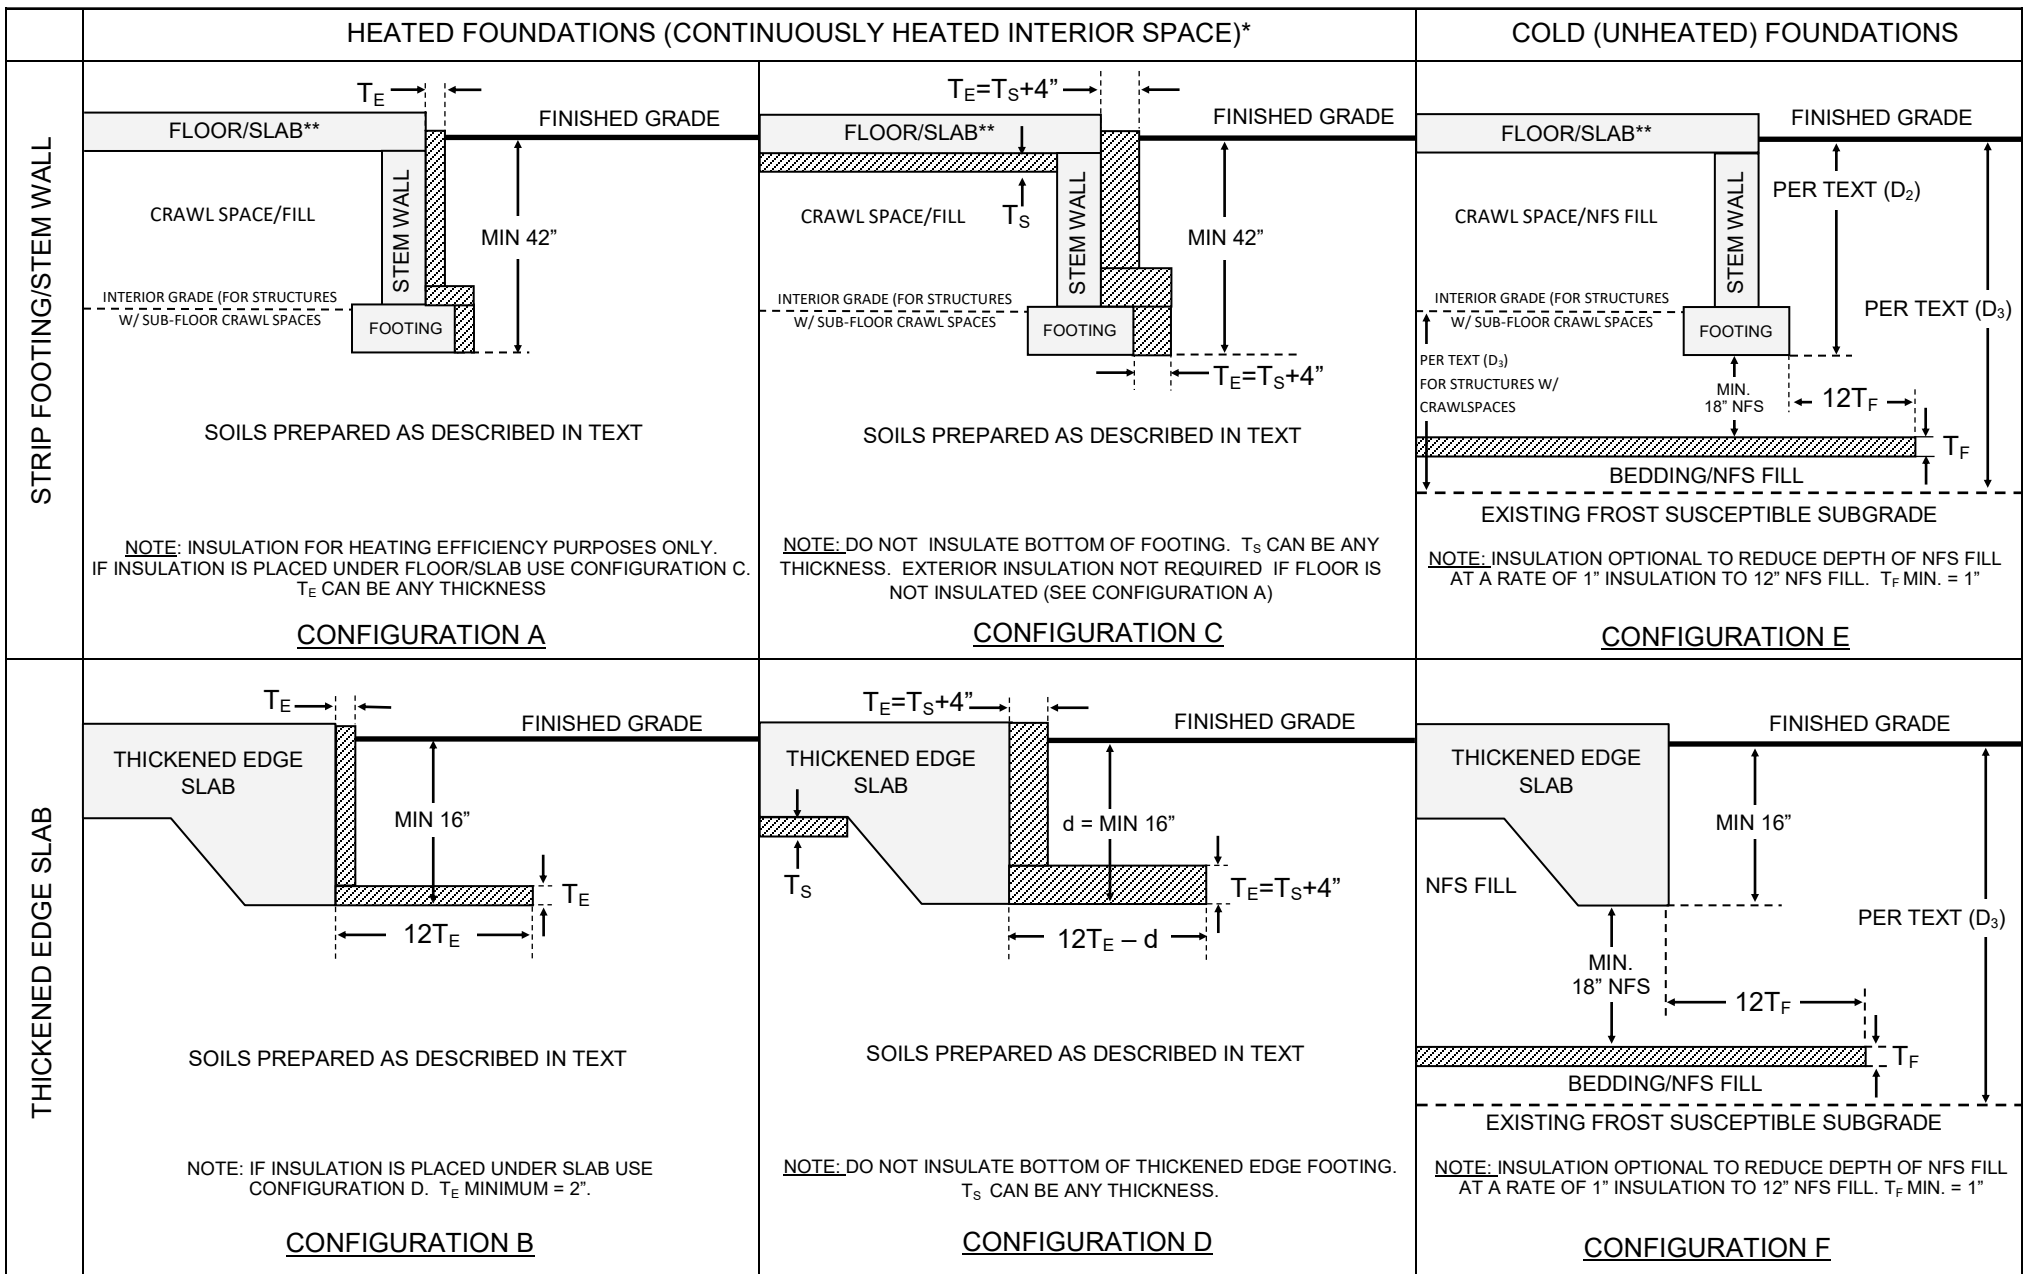
T_F = INSULATION THICKNESS UNDER ENTIRE FOUNDATION (INCHES)
 T_S = INSULATION THICKNESS UNDER FLOOR/SLAB ONLY (INCHES)
 T_E = INSULATION ALONG EXTERIOR OF FOUNDATION (INCHES)

*HEATED FOUNDATION TEMPERATURE MUST BE CONTINUOUSLY MAINTAINED AT/ABOVE 40°F

We have provided our recommended insulation configurations Figure 6 of this report. We should be consulted if alternative foundation insulation configurations are to be utilized for this project so that we can evaluate their suitability as it pertains to the existing site conditions and proposed foundation design.

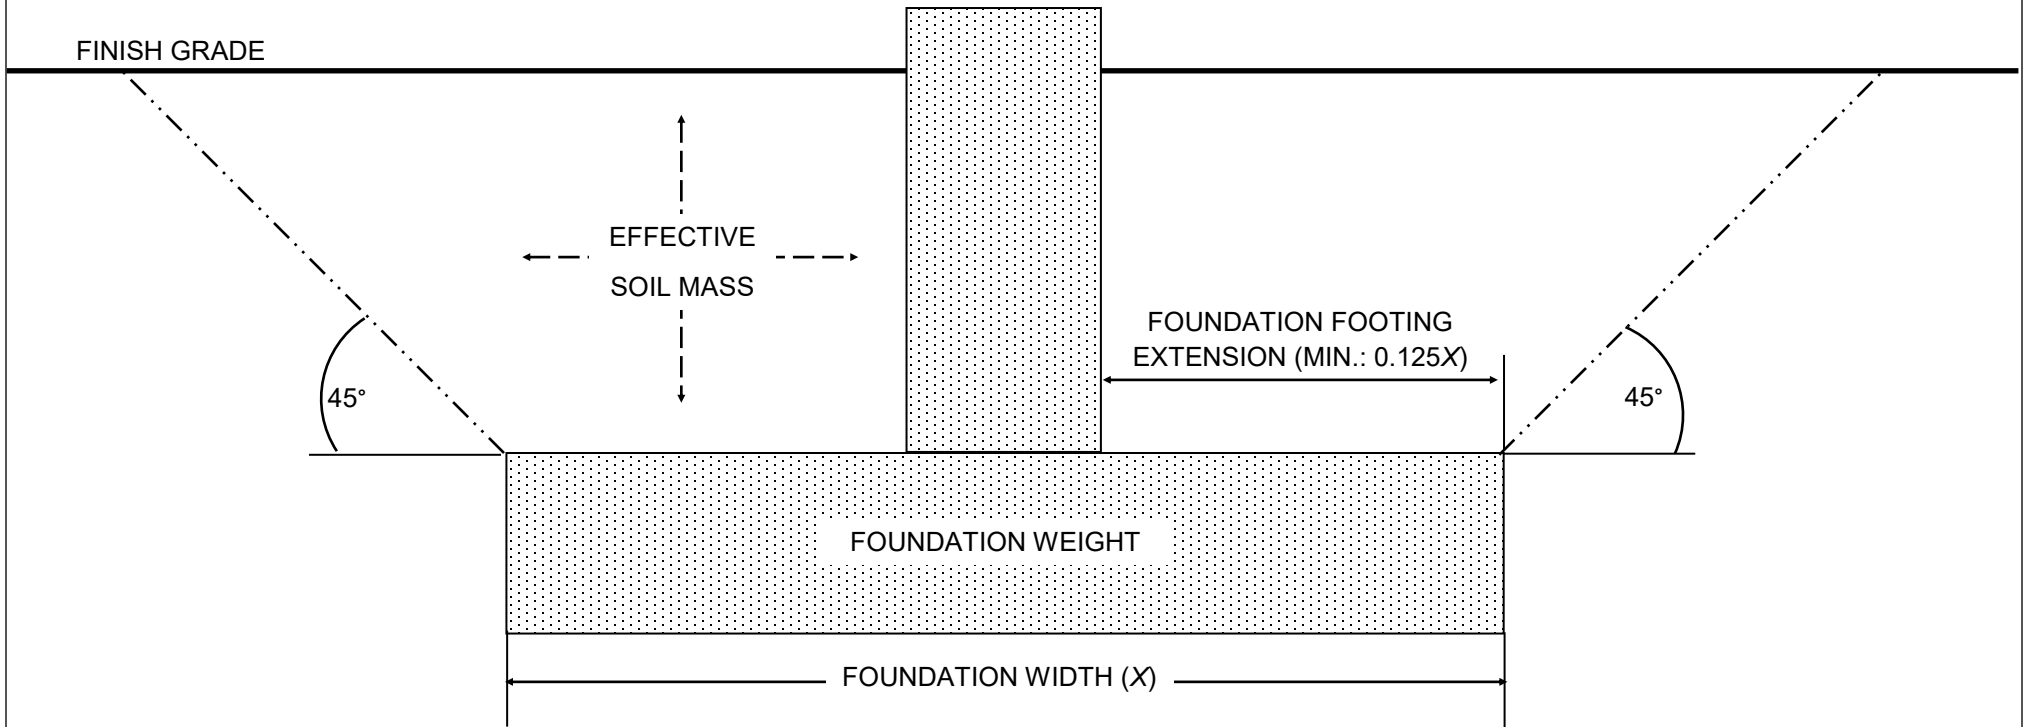
$$\text{UPLIFT CAPACITY} = 0.8 \times (\text{EFFECTIVE SOIL WEIGHT} + \text{WEIGHT OF FOUNDATION})$$

= FOOTING / STEM WALL

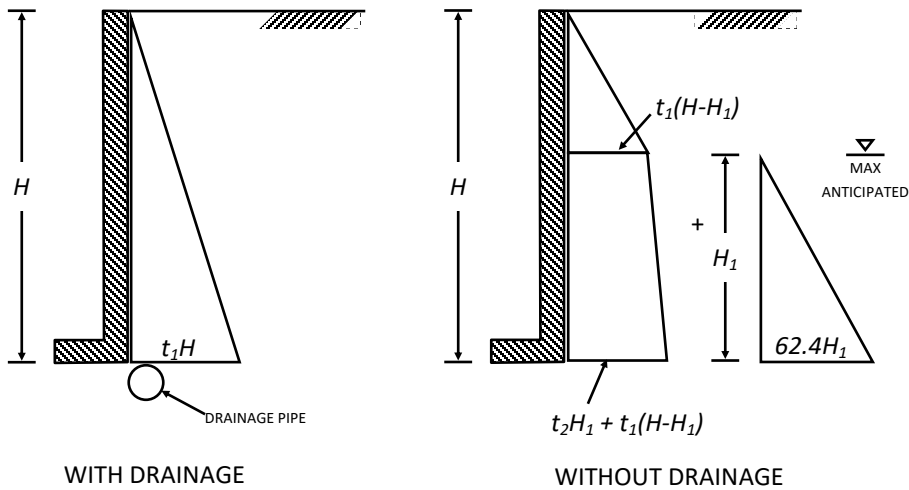
ACTIVE PRESSURE CONDITION

NOTE: WALLS CAN BE EITHER FREE OR RESTRAINED AT THE TOP FOR THE PASSIVE PRESSURE CONDITION. EQUATIONS ARE ONLY VALID FOR UNITS OF t_{1-8} (PCF) AND $H-H_1$ (FT).

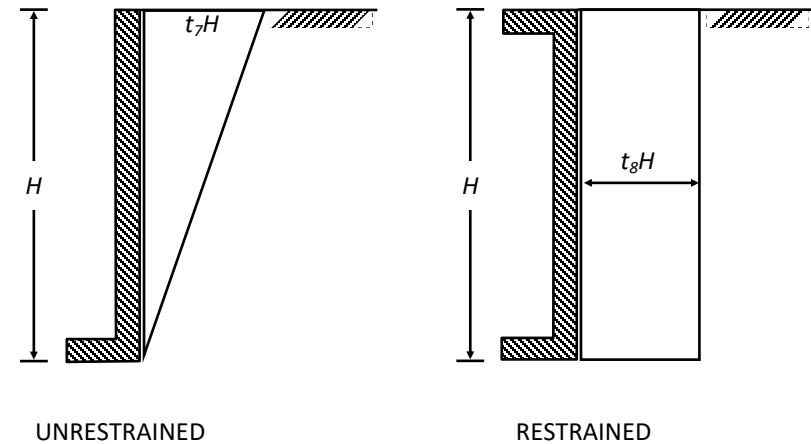
NOTE: SEISMIC LOADS ARE VALID FOR WALLS RETAINING LESS THAN 8 FEET VERTICAL OF EARTH. THE SEISMIC LOAD IS ADDED TO ACTIVE OR AT-REST CONDITIONS AND IS SUBTRACTED FROM PASSIVE CONDITIONS.

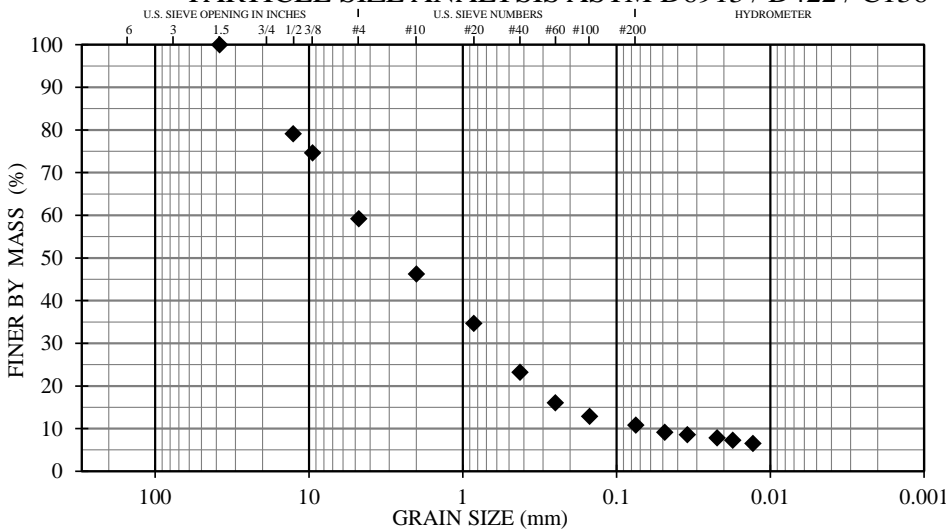
PARTICLE SIZE ANALYSIS ASTM D6913 / D422 / C136

COBBLES	GRAVEL		SAND			SILT or CLAY
	Coarse	Fine	Coarse	Medium	Fine

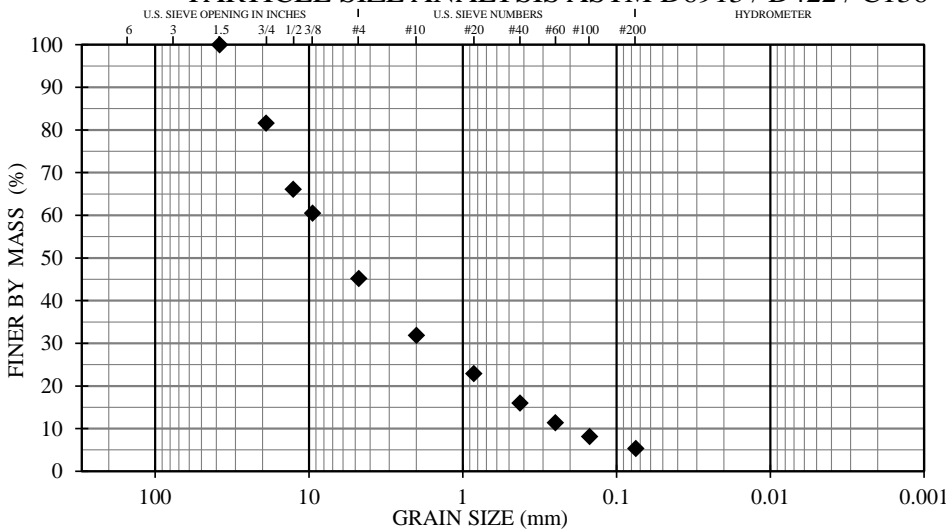
PARTICLE SIZE ANALYSIS ASTM D6913 / D422 / C136

% GRAVEL	54.8	USCS	GW-GM
% SAND	39.8	USACOE FC	N/A
% SILT/CLAY	5.4	% PASS. 0.02 mm	N/A
% MOIST. CONTENT	2.4	% PASS. 0.002 mm	N/A
UNIFORMITY COEFFICIENT (C_u)		45.1	
COEFFICIENT OF GRADATION (C_c)		1.6	
ASTM D1557 (uncorrected)		N/A	
ASTM D4718 (corrected)		N/A	
OPTIMUM MOIST. CONTENT. (corrected)		N/A

SIEVE ANALYSIS RESULT

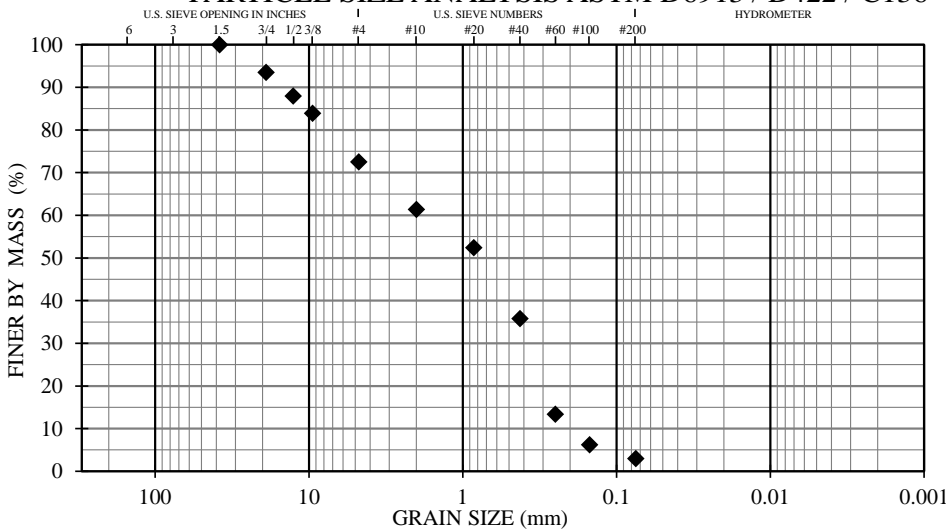
PARTICLE SIZE ANALYSIS ASTM D6913 / D422 / C136

% GRAVEL	27.5	USCS	SP
% SAND	69.5	USACOE FC	N/A
% SILT/CLAY	3.0	% PASS. 0.02 mm	N/A
% MOIST. CONTENT	4.7	% PASS. 0.002 mm	N/A
UNIFORMITY COEFFICIENT (C_u)		9.0	
COEFFICIENT OF GRADATION (C_c)		0.4	
ASTM D1557 (uncorrected)		N/A	
ASTM D4718 (corrected)		N/A	
OPTIMUM MOIST. CONTENT. (corrected)		N/A

SIEVE ANALYSIS RESULT

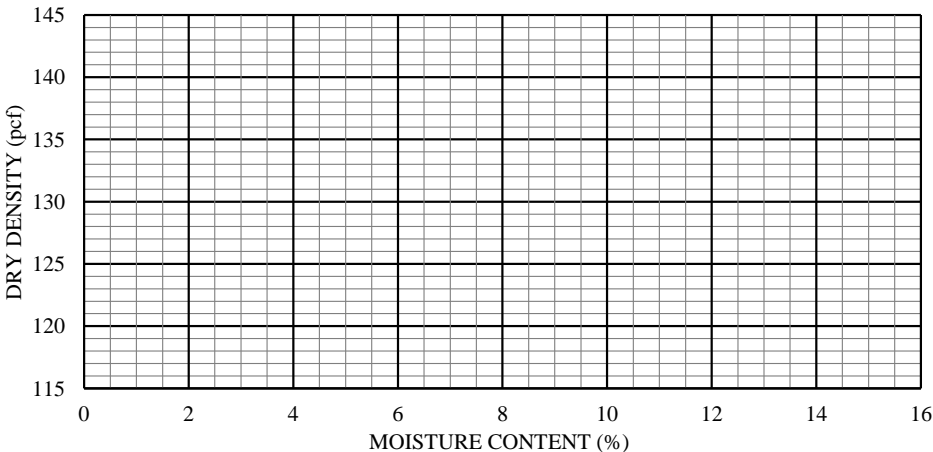
MOISTURE-DENSITY RELATIONSHIP ASTM D1557

HYDRAULIC COND. (ASTM D2434)	N/A
DEGRADATION (ATM T-313)	N/A
PLASTICITY INDEX ASTM 4318	N/A

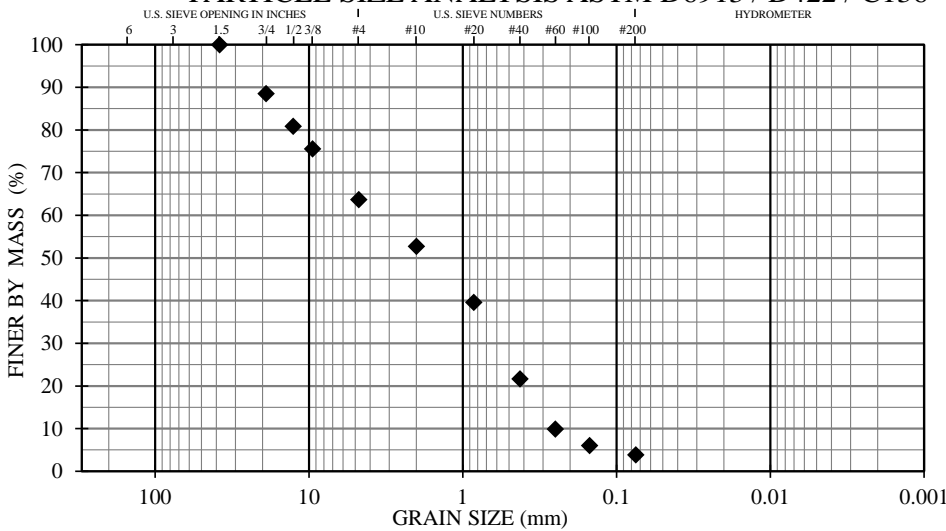
PARTICLE SIZE ANALYSIS ASTM D6913 / D422 / C136

% GRAVEL	36.3	USCS	SP
% SAND	59.9	USACOE FC	N/A
% SILT/CLAY	3.8	% PASS. 0.02 mm	N/A
% MOIST. CONTENT	3.5	% PASS. 0.002 mm	N/A
UNIFORMITY COEFFICIENT (C_u)		15.2	
COEFFICIENT OF GRADATION (C_c)		0.4	
ASTM D1557 (uncorrected)		N/A	
ASTM D4718 (corrected)		N/A	
OPTIMUM MOIST. CONTENT. (corrected)		N/A

SIEVE ANALYSIS RESULT

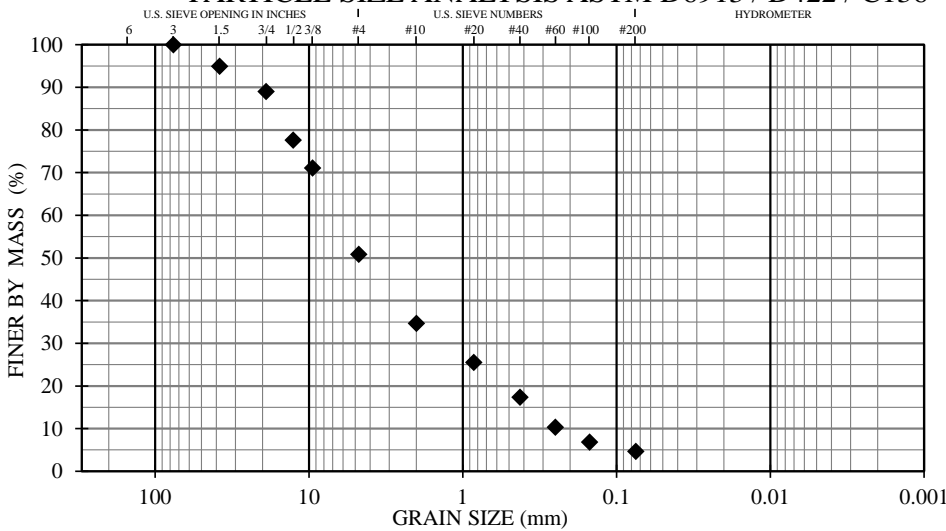
PARTICLE SIZE ANALYSIS ASTM D6913 / D422 / C136

% GRAVEL	49.1	USCS	GW
% SAND	46.2	USACOE FC	N/A
% SILT/CLAY	4.7	% PASS. 0.02 mm	N/A
% MOIST. CONTENT	3.7	% PASS. 0.002 mm	N/A
UNIFORMITY COEFFICIENT (C_u)		28.7	
COEFFICIENT OF GRADATION (C_c)		1.2	
ASTM D1557 (uncorrected)		N/A	
ASTM D4718 (corrected)		N/A	
OPTIMUM MOIST. CONTENT. (corrected)		N/A

SIEVE ANALYSIS RESULT

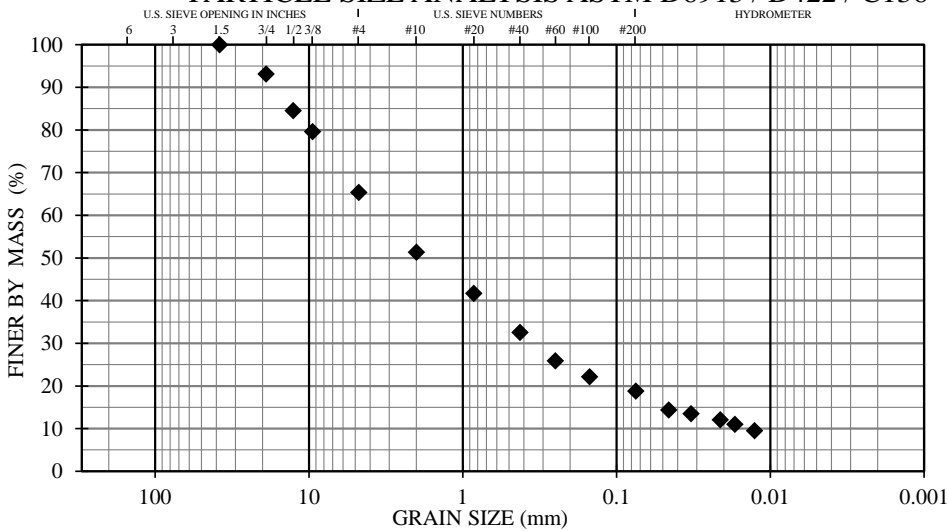
PARTICLE SIZE ANALYSIS ASTM D6913 / D422 / C136

% GRAVEL	34.7	USCS	SM
% SAND	46.5	USACOE FC	F2
% SILT/CLAY	18.8	% PASS. 0.02 mm	11.8
% MOIST. CONTENT	7.2	% PASS. 0.002 mm	N/A
UNIFORMITY COEFFICIENT (C _u)		263.6	
COEFFICIENT OF GRADATION (C _c)		2.5	
ASTM D1557 (uncorrected)		N/A	
ASTM D4718 (corrected)		N/A	
OPTIMUM MOIST. CONTENT. (corrected)		N/A

SIEVE ANALYSIS RESULT

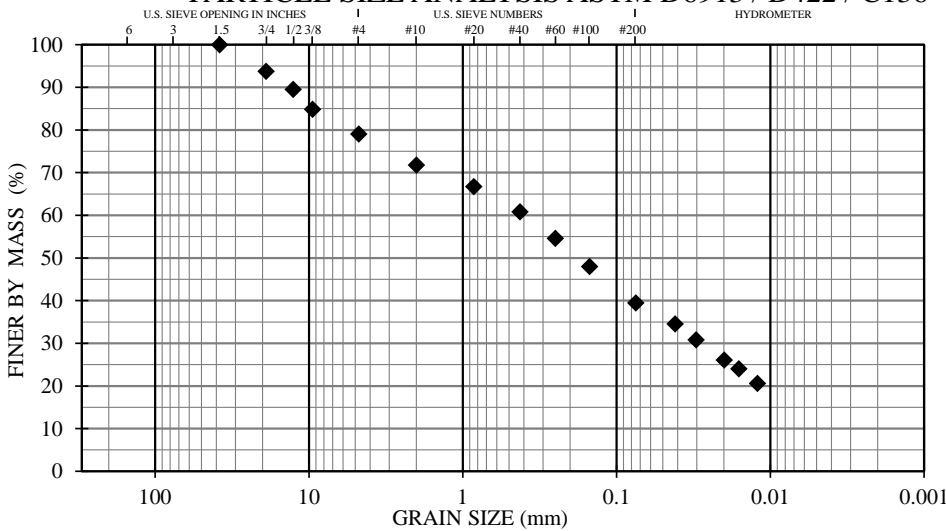
PARTICLE SIZE ANALYSIS ASTM D6913 / D422 / C136

COBBLES	GRAVEL		SAND			SILT or CLAY
	Coarse	Fine	Coarse	Medium	Fine

SIEVE SIZE (mm)	SIEVE SIZE (U.S.)	TOTAL % PASSING	SPECIFICATION (% PASSING)
152.40	6"		
76.20	3"		
38.10	1.5"	100	
19.00	3/4"	94	
12.70	1/2"	90	
9.50	3/8"	85	
4.75	#4	79	
2.00	#10	72	
0.85	#20	67	
0.43	#40	61	
0.25	#60	55	
0.15	#100	48	
0.075	#200	39.5

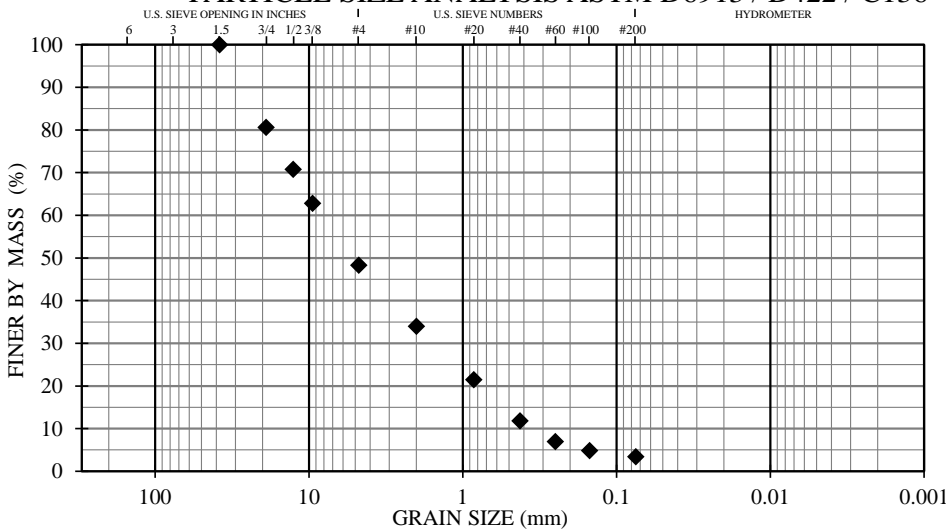
PARTICLE SIZE ANALYSIS ASTM D6913 / D422 / C136

% GRAVEL	51.7	USCS	GP
% SAND	44.9	USACOE FC	N/A
% SILT/CLAY	3.4	% PASS. 0.02 mm	N/A
% MOIST. CONTENT	2.4	% PASS. 0.002 mm	N/A
UNIFORMITY COEFFICIENT (C _u)		23.9	
COEFFICIENT OF GRADATION (C _c)		0.9	
ASTM D1557 (uncorrected)		N/A	
ASTM D4718 (corrected)		N/A	
OPTIMUM MOIST. CONTENT. (corrected)		N/A

SIEVE ANALYSIS RESULT

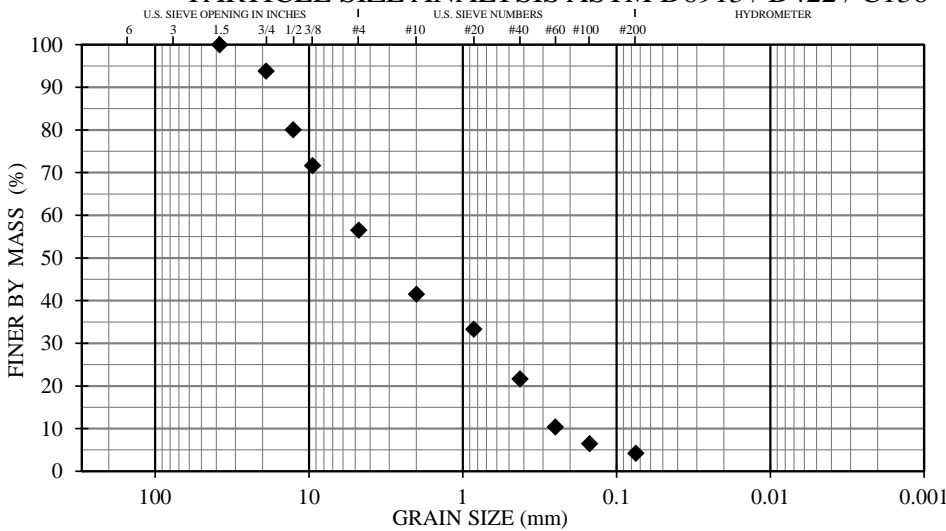
PARTICLE SIZE ANALYSIS ASTM D6913 / D422 / C136

SIEVE SIZE (mm)	SIEVE SIZE (U.S.)	TOTAL % PASSING	SPECIFICATION (% PASSING)
152.40	6"		
76.20	3"		
38.10	1.5"	100	
19.00	3/4"	94	
12.70	1/2"	80	
9.50	3/8"	72	
4.75	#4	57	
2.00	#10	42	
0.85	#20	33	
0.43	#40	22	
0.25	#60	10	
0.15	#100	6	
0.075	#200	4.2

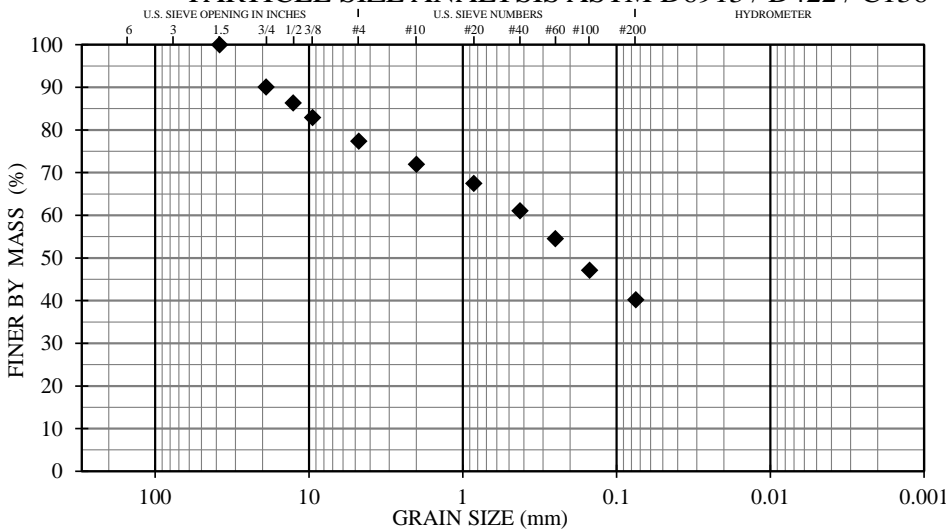
PARTICLE SIZE ANALYSIS ASTM D6913 / D422 / C136

SIEVE SIZE (mm)	SIEVE SIZE (U.S.)	TOTAL % PASSING	SPECIFICATION (% PASSING)
152.40	6"		
76.20	3"		
38.10	1.5"	100	
19.00	3/4"	90	
12.70	1/2"	86	
9.50	3/8"	83	
4.75	#4	77	
2.00	#10	72	
0.85	#20	68	
0.43	#40	61	
0.25	#60	55	
0.15	#100	47	
0.075	#200	40.2

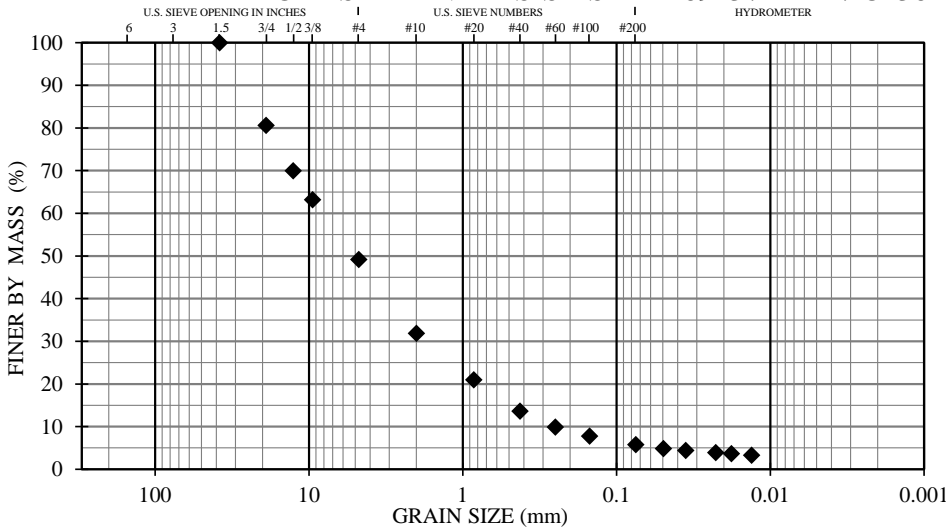
PARTICLE SIZE ANALYSIS ASTM D6913 / D422 / C136

% GRAVEL	50.8	USCS	GW-GM
% SAND	43.4	USACOE FC	S1
% SILT/CLAY	5.8	% PASS. 0.02 mm	3.8
% MOIST. CONTENT	2.6	% PASS. 0.002 mm	N/A
UNIFORMITY COEFFICIENT (C _u)		33.1	
COEFFICIENT OF GRADATION (C _c)		1.5	
ASTM D1557 (uncorrected)		N/A	
ASTM D4718 (corrected)		N/A	
OPTIMUM MOIST. CONTENT. (corrected)		N/A

SIEVE ANALYSIS RESULT

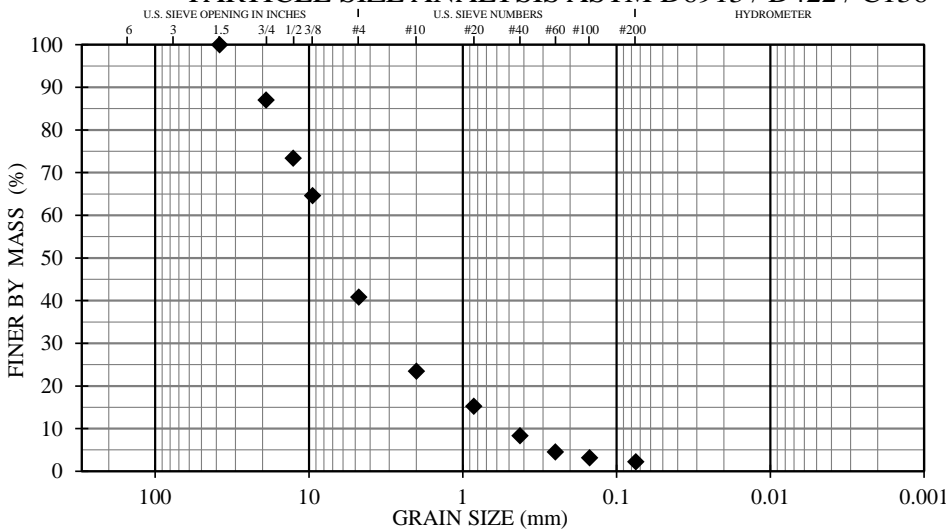
PARTICLE SIZE ANALYSIS ASTM D6913 / D422 / C136

% GRAVEL	59.2	USCS	GW
% SAND	38.6	USACOE FC	N/A
% SILT/CLAY	2.2	% PASS. 0.02 mm	N/A
% MOIST. CONTENT	1.9	% PASS. 0.002 mm	N/A
UNIFORMITY COEFFICIENT (C _u)		16.3	
COEFFICIENT OF GRADATION (C _c)		2.0	
ASTM D1557 (uncorrected)		N/A	
ASTM D4718 (corrected)		N/A	
OPTIMUM MOIST. CONTENT. (corrected)		N/A

SIEVE ANALYSIS RESULT

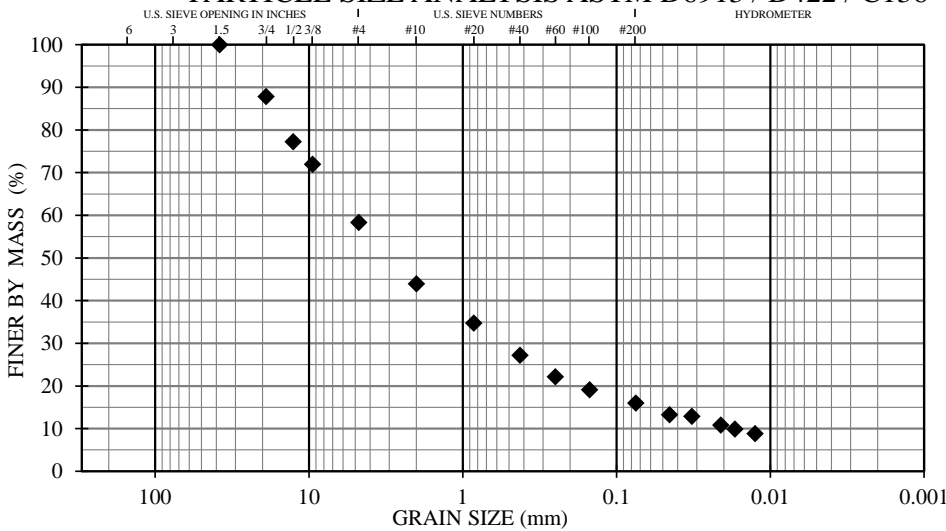
PARTICLE SIZE ANALYSIS ASTM D6913 / D422 / C136

% GRAVEL	41.7	USCS	SM
% SAND	42.3	USACOE FC	F2
% SILT/CLAY	16.0	% PASS. 0.02 mm	10.5
% MOIST. CONTENT	6.1	% PASS. 0.002 mm	N/A
UNIFORMITY COEFFICIENT (C _u)		306.1	
COEFFICIENT OF GRADATION (C _c)		3.7	
ASTM D1557 (uncorrected)		N/A	
ASTM D4718 (corrected)		N/A	
OPTIMUM MOIST. CONTENT. (corrected)		N/A

SIEVE ANALYSIS RESULT

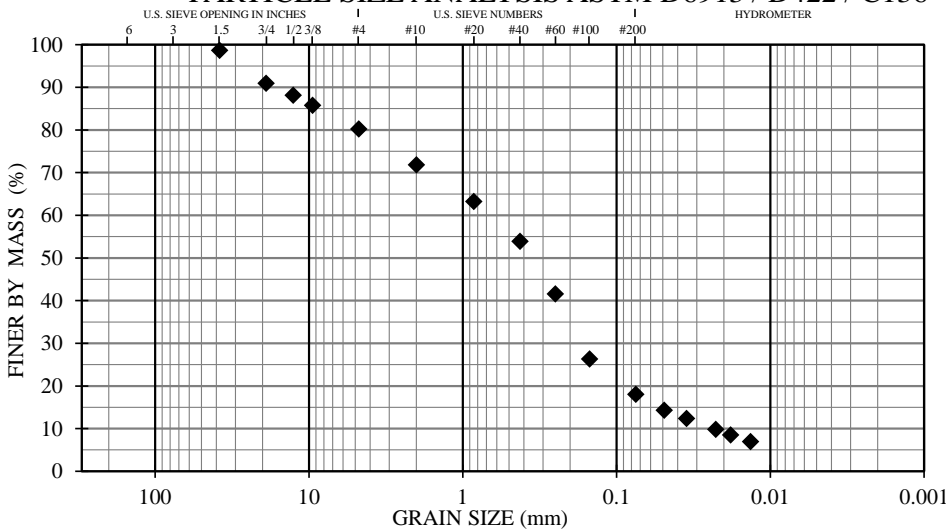
PARTICLE SIZE ANALYSIS ASTM D6913 / D422 / C136

% GRAVEL	19.8	USCS	SM
% SAND	62.2	USACOE FC	F2
% SILT/CLAY	18.0	% PASS. 0.02 mm	9.1
% MOIST. CONTENT	14.4	% PASS. 0.002 mm	N/A
UNIFORMITY COEFFICIENT (C _u)		29.9	
COEFFICIENT OF GRADATION (C _c)		1.8	
ASTM D1557 (uncorrected)		N/A	
ASTM D4718 (corrected)		N/A	
OPTIMUM MOIST. CONTENT. (corrected)		N/A

SIEVE ANALYSIS RESULT

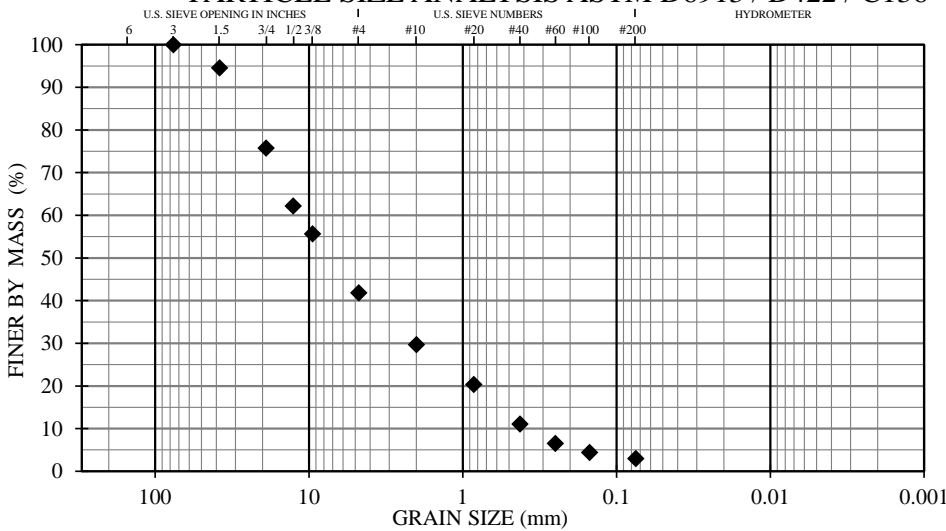
PARTICLE SIZE ANALYSIS ASTM D6913 / D422 / C136

% GRAVEL	58.2	USCS	GP
% SAND	38.9	USACOE FC	N/A
% SILT/CLAY	2.9	% PASS. 0.02 mm	N/A
% MOIST. CONTENT	2.7	% PASS. 0.002 mm	N/A
UNIFORMITY COEFFICIENT (C_u)		30.3	
COEFFICIENT OF GRADATION (C_c)		1.0	
ASTM D1557 (uncorrected)		N/A	
ASTM D4718 (corrected)		N/A	
OPTIMUM MOIST. CONTENT. (corrected)		N/A

SIEVE ANALYSIS RESULT

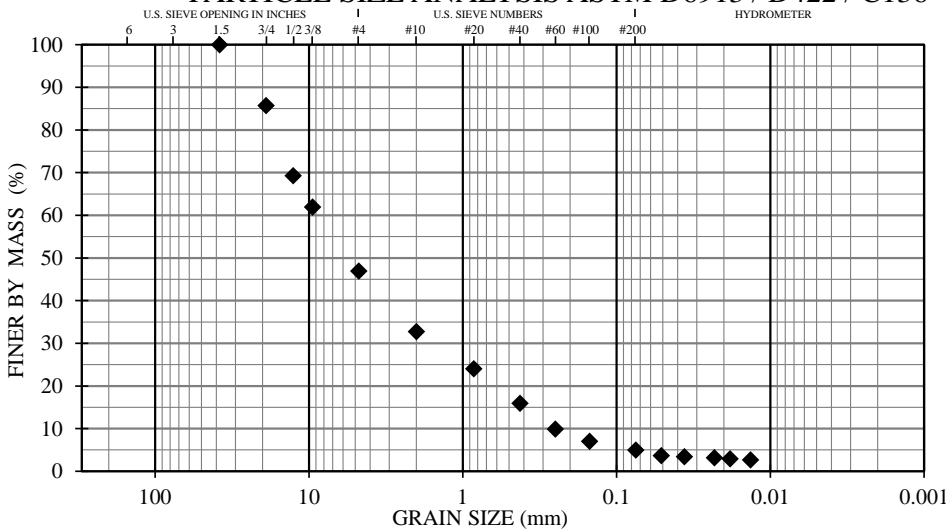
PARTICLE SIZE ANALYSIS ASTM D6913 / D422 / C136

% GRAVEL	53.0	USCS	GW-GM
% SAND	42.0	USACOE FC	PFS
% SILT/CLAY	5.0	% PASS. 0.02 mm	3.0
% MOIST. CONTENT	2.6	% PASS. 0.002 mm	N/A
UNIFORMITY COEFFICIENT (C_u)		35.1	
COEFFICIENT OF GRADATION (C_c)		1.2	
ASTM D1557 (uncorrected)		N/A	
ASTM D4718 (corrected)		N/A	
OPTIMUM MOIST. CONTENT. (corrected)		N/A

SIEVE ANALYSIS RESULT

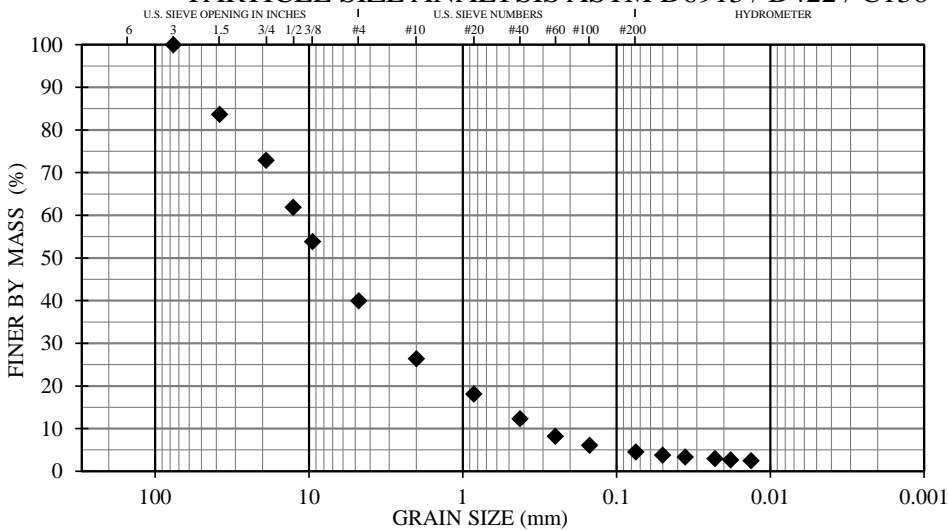
PARTICLE SIZE ANALYSIS ASTM D6913 / D422 / C136

% GRAVEL	60.0	USCS	GW
% SAND	35.5	USACOE FC	PFS
% SILT/CLAY	4.5	% PASS. 0.02 mm	2.7
% MOIST. CONTENT	2.2	% PASS. 0.002 mm	N/A
UNIFORMITY COEFFICIENT (C _u)		36.7	
COEFFICIENT OF GRADATION (C _c)		1.9	
ASTM D1557 (uncorrected)		N/A	
ASTM D4718 (corrected)		N/A	
OPTIMUM MOIST. CONTENT. (corrected)		N/A

SIEVE ANALYSIS RESULT
