GEOTECHNICAL ENGINEERING REPORT

ACLT KITCHEN ANCHORAGE, ALASKA

NGE-TFT Project #7289-25

**RE: GEOTECHNICAL ENGINEERING ASSESSMENT FOR THE PROPOSED ACLT
KITCHEN LOCATED IN THE MOUNTAIN VIEW SUBDIVISION –
ANCHORAGE, ALASKA**

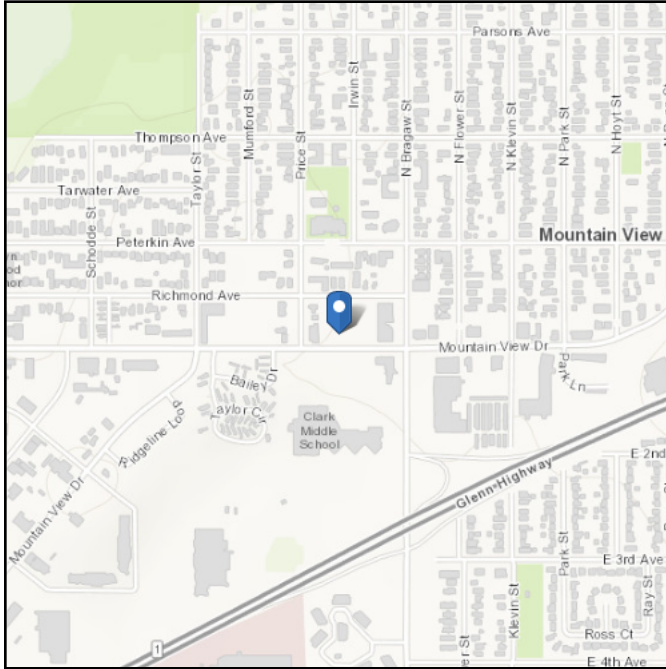
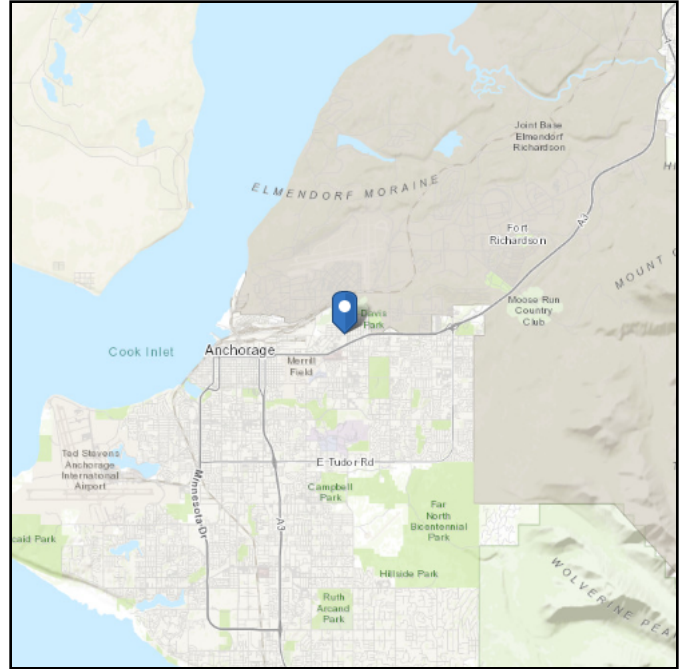
Site Soil Class: D - Stiff Soil

PGA _M :	0.53	T _L :	16
S _{MS} :	1.62	S _s :	1.5
S _{M1} :	1.86	S ₁ :	0.65
S _{DS} :	1.08	V _{S30} :	260
S _{D1} :	1.24

Seismic Design Category: D
